Response to your request for official information

"1) For the critical buildings assessed for the NAMP programme but not self-assessed by DHBs, please provide - for all mental health and intellectual disability units - any data/information/documents that informed the publication of the NAMP report for these units."

Please note data presented in the Clinical Facility Fitness for Purpose reports is raw data. The raw data is then standardised into a 1 – 5 scoring matrix to remain consistent with the other National Asset Management Programme's data outputs. On this spectrum, a score of 1 is considered good and a score of 5 is considered to be poor.

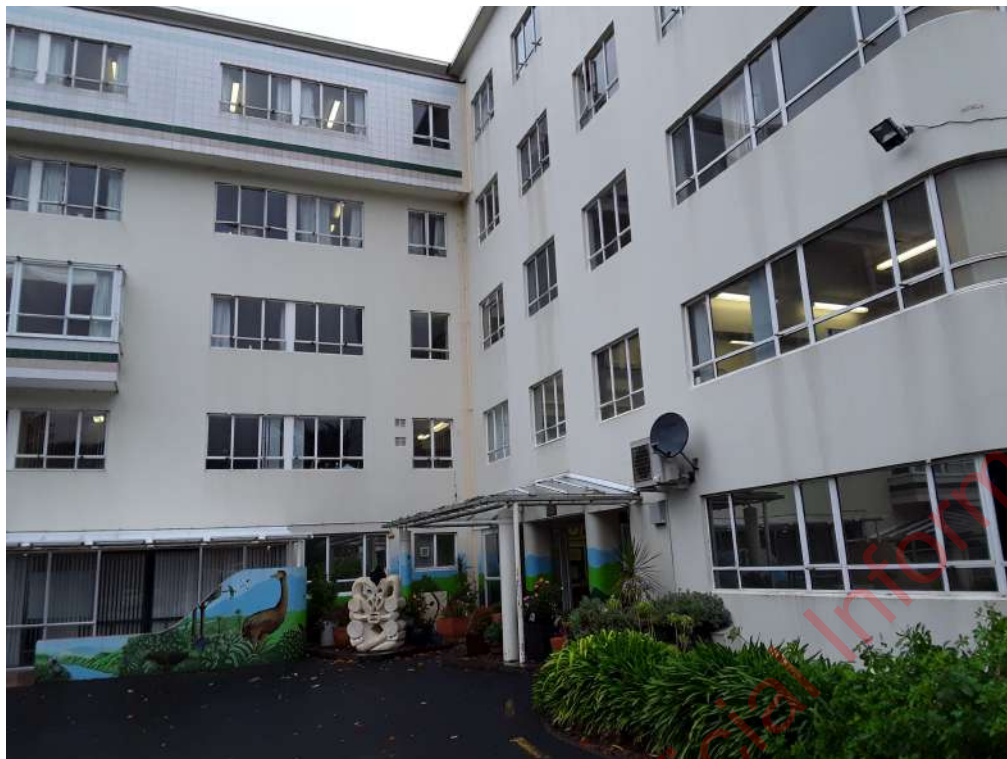
Photo of Building Exterior

Services & Fabric Score

3.3

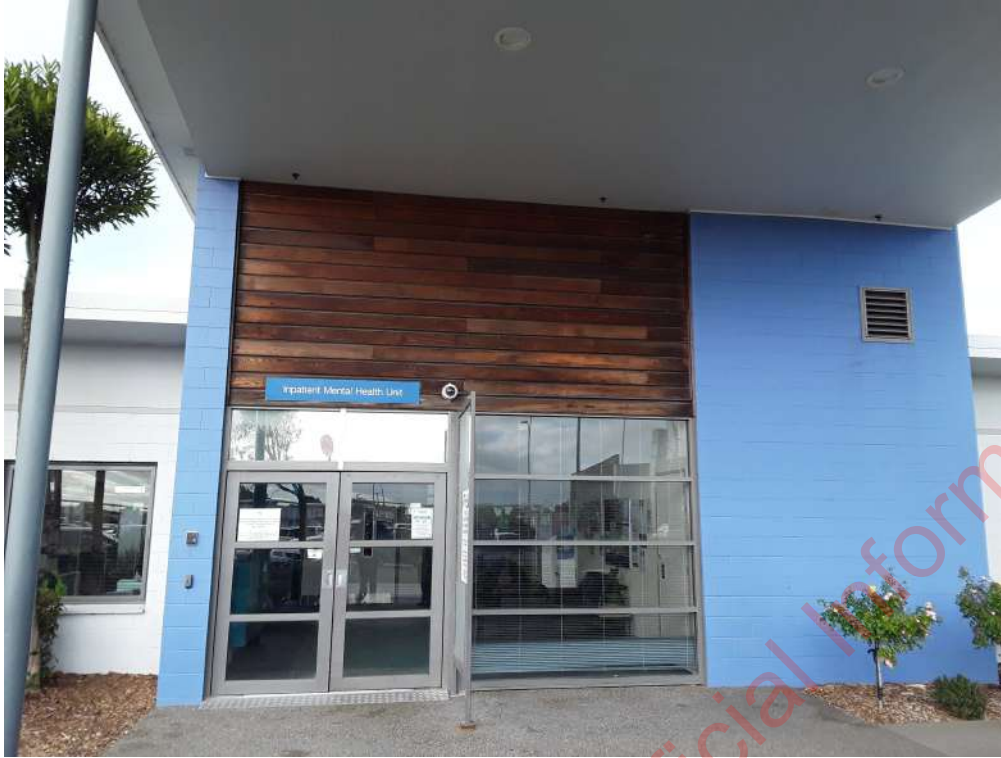
Photo of Building Exterior

Services & Fabric Score

2.5

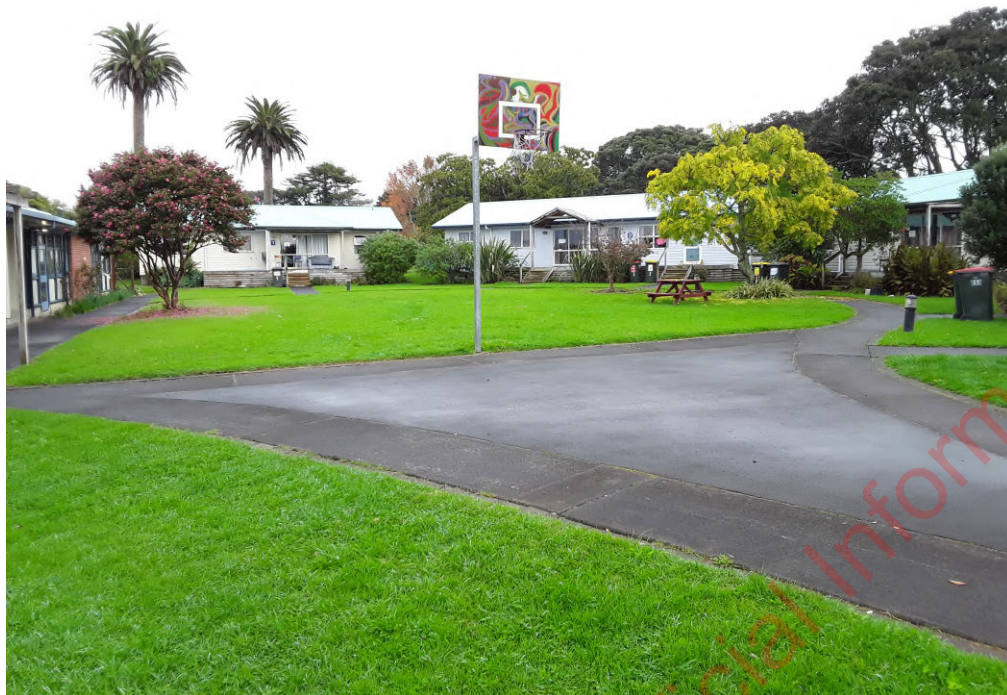
Photo of Building Exterior

Services & Fabric Score

2.8

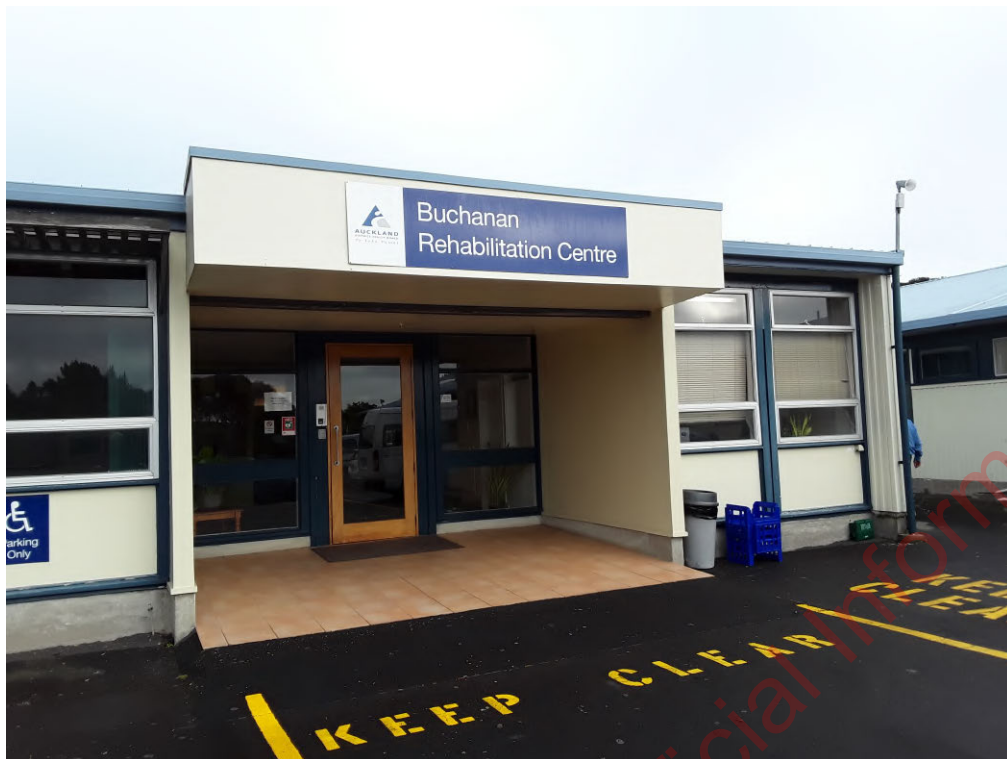
Photo of Building Exterior

Services & Fabric Score

3.2

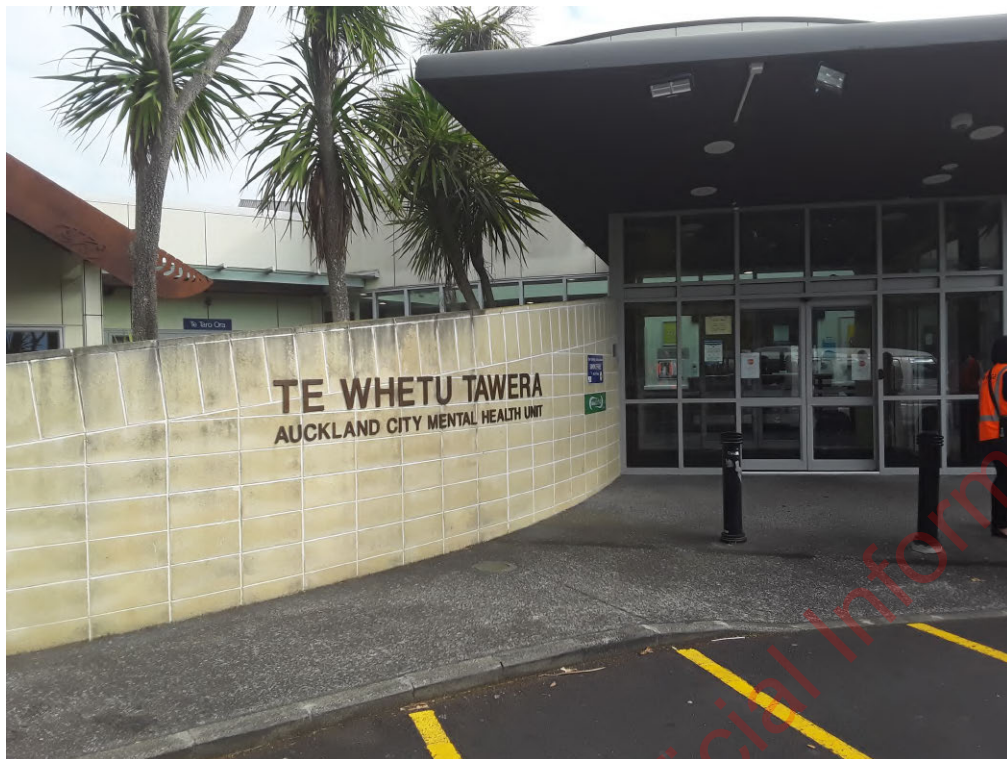
Photo of Building Exterior

Services & Fabric Score

2.5

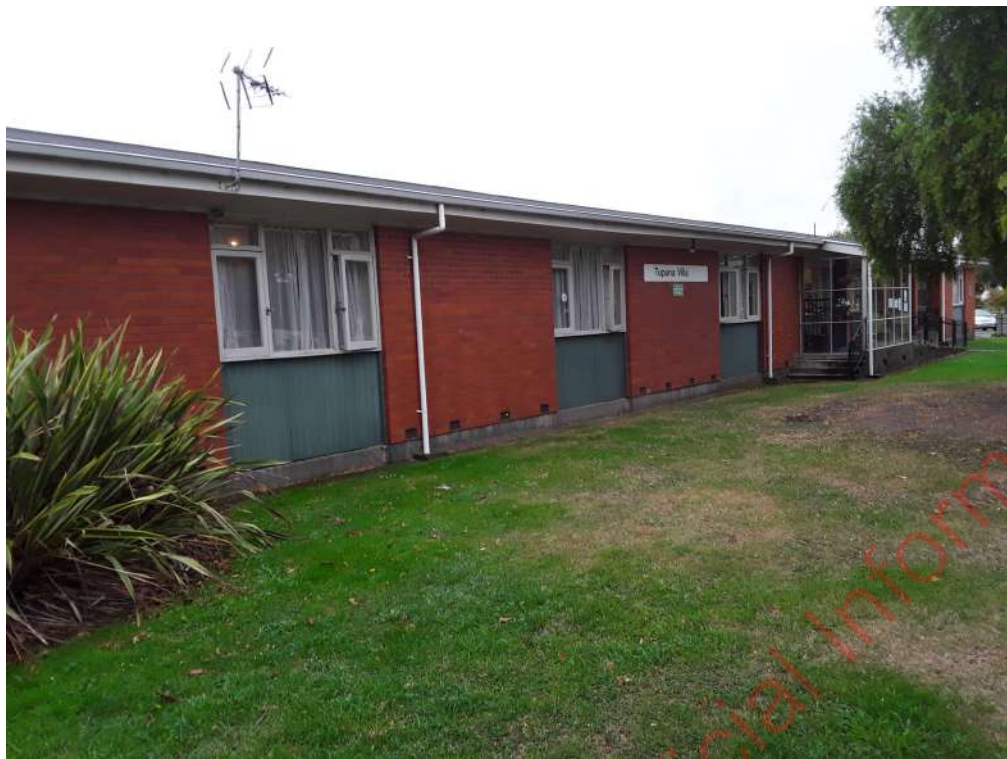
Photo of Building Exterior

Services & Fabric Score

2.9

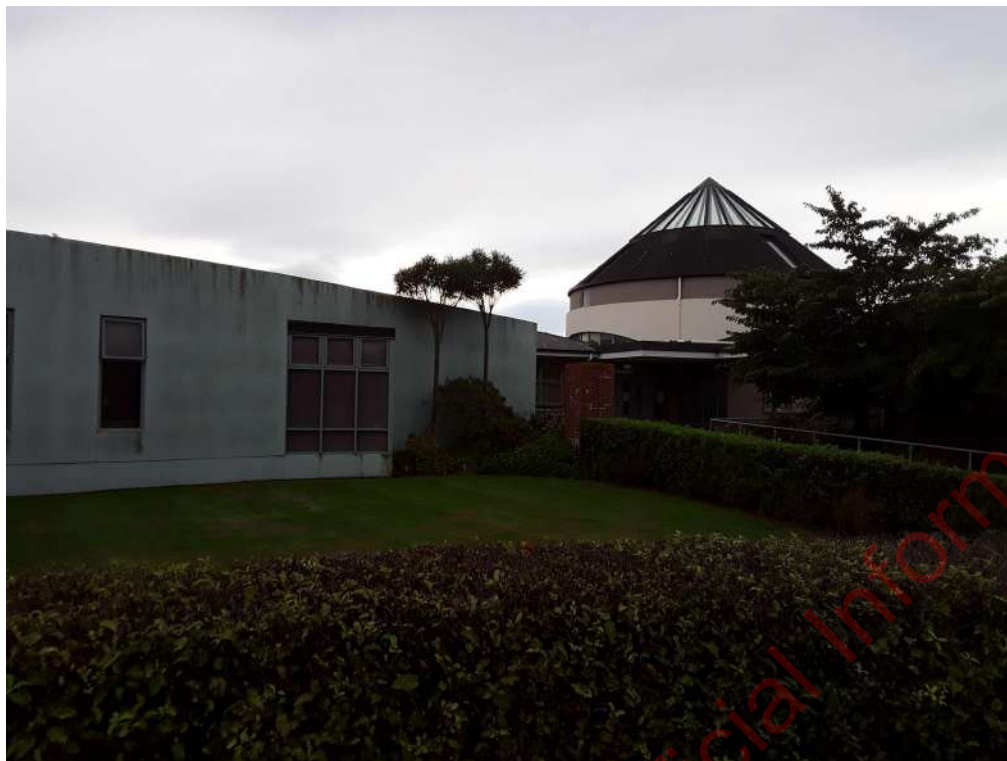
Photo of Building Exterior

Services & Fabric Score

2.3

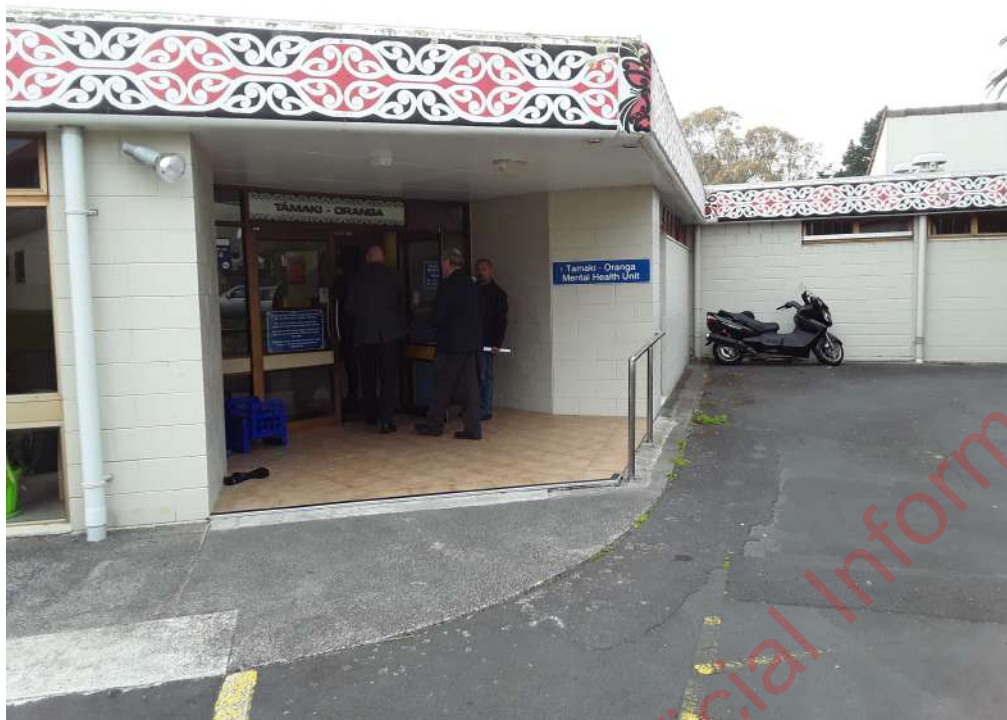
Photo of Building Exterior

Services & Fabric Score

3.4

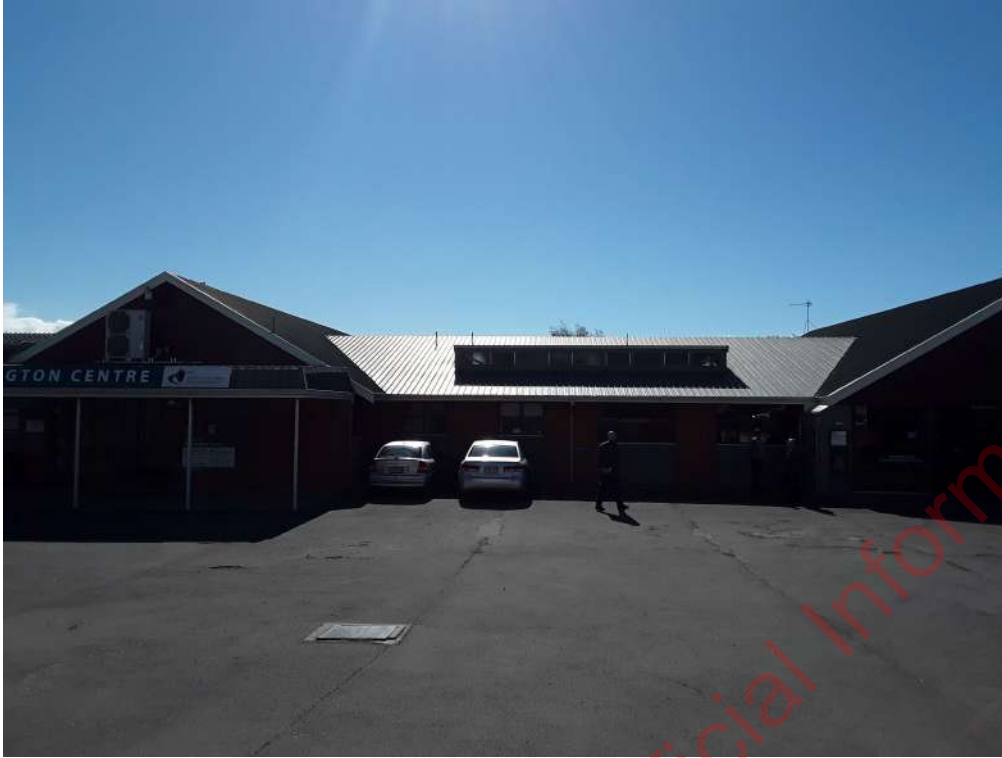
Photo of Building Exterior

Services & Fabric Score

2.2
