NAMP DHB Asset Condition Self Assessment

Data Standard and Methodology

Prepared for Ministry of Health
Prepared by Beca Limited

14 June 2019

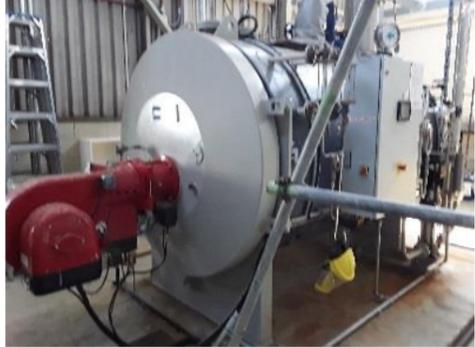
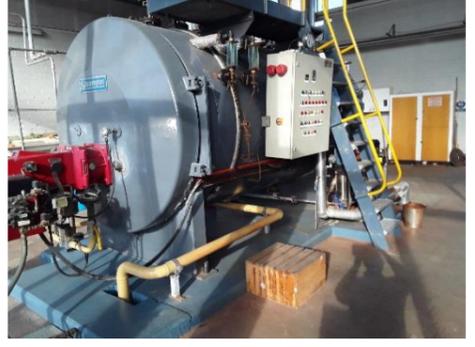
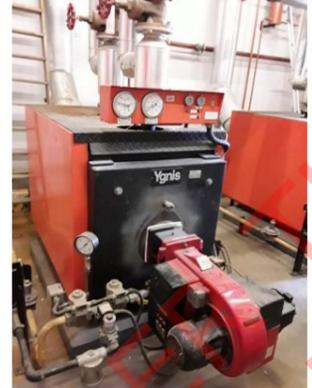
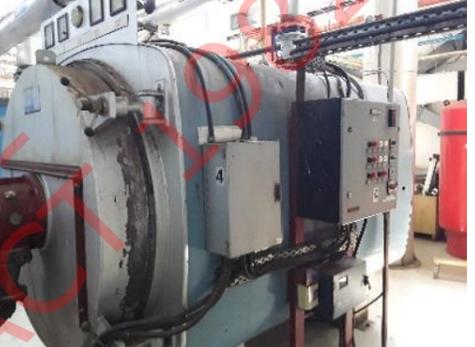
| Element example | 1 - Very Good | 2 - Good | 3 - Average | 4 - Poor | 5 - Very Poor |
|---|---|---|--|---|---|
| Boilers | <p>New, surface clean, free of damage, no surface rust,</p> | <p>Visibly good condition. Aged but evidence of replacement and refurbishment. In good working order</p> | <p>Aged asset at/near economic life expiry. In working order but further deterioration is likely</p> | <p>Surface showing signs of deterioration, old controls, aged condition can anticipate at/near useful economic life. Discussion also with operator on frequency of failure etc, not new</p> | |

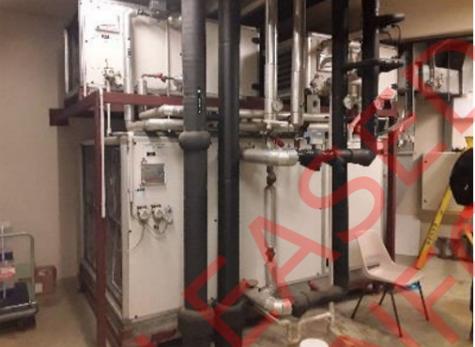
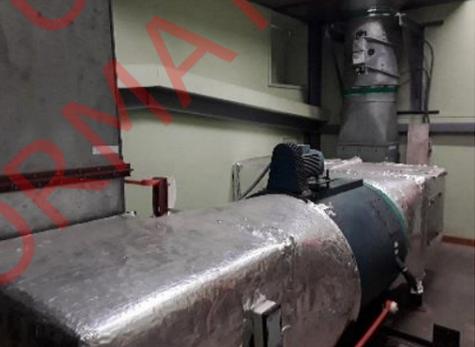
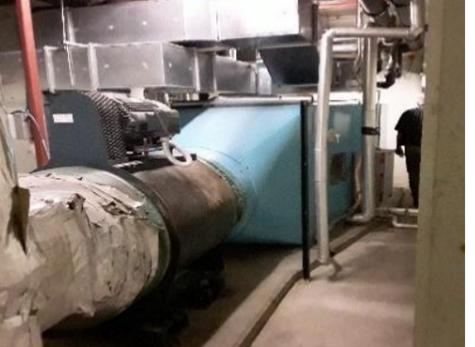
| Element example | 1 - Very Good | 2 - Good | 3 - Average | 4 - Poor | 5 - Very Poor |
|---|---|---|--|---|---|
| AHU | | <p>Generally clean and tidy appearance, no damage evident, not new</p> | <p>Unclean / untidy appearance, unclad in accessed areas, prone to damage, signs of insulation deterioration, old</p> | <p>Unclean / untidy appearance, signs of insulation deterioration, very old</p> | |

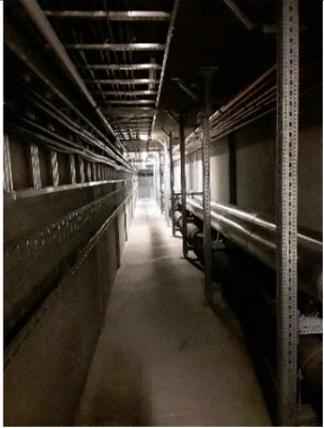
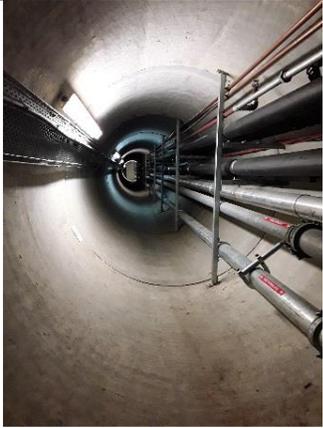
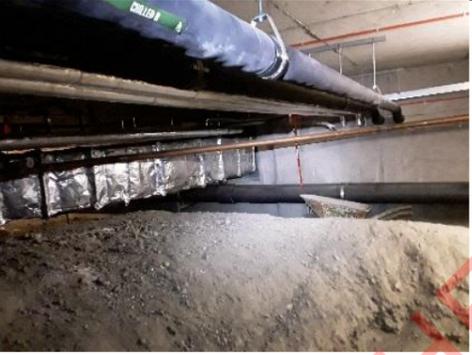
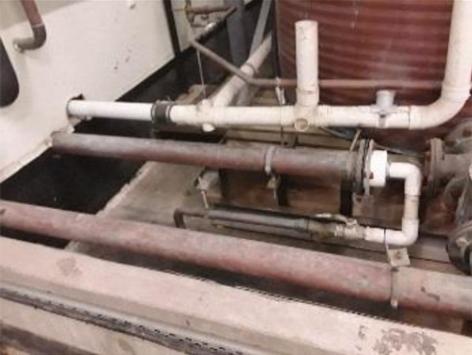
| Element example | 1 - Very Good | 2 - Good | 3 - Average | 4 - Poor | 5 - Very Poor |
|---|--|--|---|---|--|
| Pipework | <p data-bbox="403 699 878 827">New, good spatial layout and accessible for maintenance. Level access. Seismic restraint and support. Pipework clad</p> | <p data-bbox="908 699 1383 827">Good spatial layout and accessible for maintenance. Seismic restraint evident support. Pipework clad. Unlevel access. Not new</p> | <p data-bbox="1412 625 1887 753">Variable condition, support and restrain non seismic and/or missing. Some deterioration evident. Variable layout (crossovers etc). Not new</p> | | <p data-bbox="2412 625 2887 787">Old, evident has been subject to numerous localised 'bandaid' type maintenance. Unclean, dirty, missing components. Poor layout and arrangement</p> |

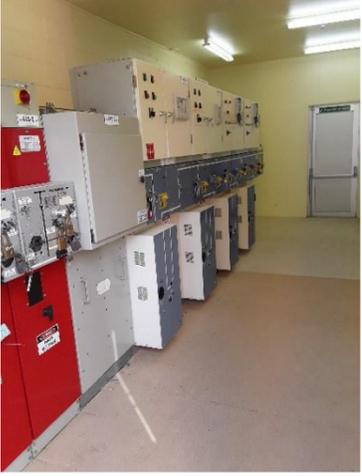
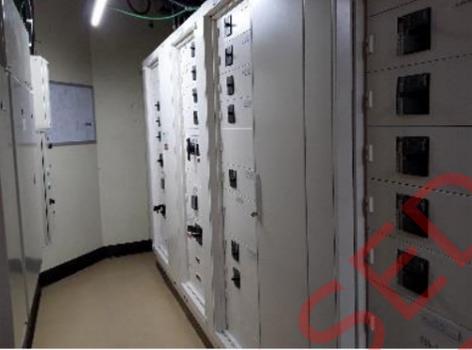
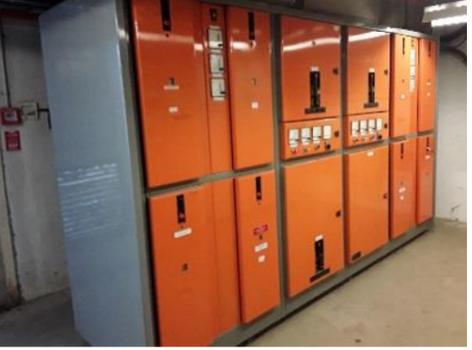
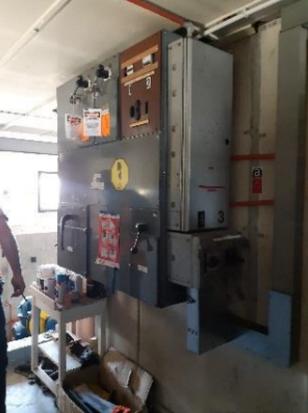
| Element example | 1 - Very Good | 2 - Good | 3 - Average | 4 - Poor | 5 - Very Poor |
|---|--|--|---|---|--|
| Switchboard | <p data-bbox="552 1367 730 1398">New condition</p> | <p data-bbox="952 1245 1338 1373">In new condition and generally appears to be well maintained. Maintenance access is slightly restricted, but compliant.</p> | | <p data-bbox="1917 1245 2392 1339">Whilst in good condition, reliability is unknown and replacement equipment is unavailable</p> | <p data-bbox="2412 1308 2887 1373">In poor overall condition with unknown reliability</p> |

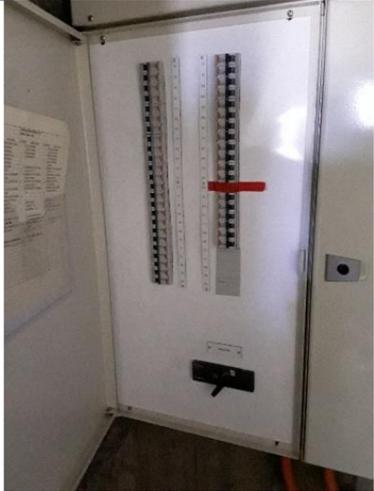
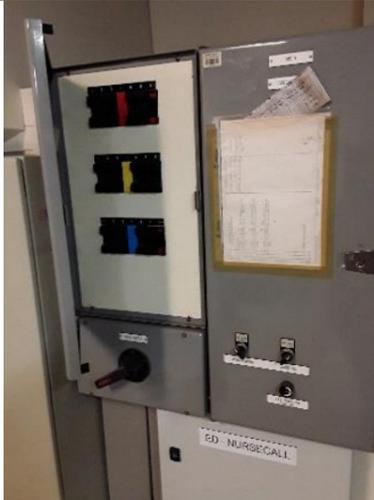
| Element example | 1 - Very Good | 2 - Good | 3 - Average | 4 - Poor | 5 - Very Poor |
|---|---|--|---|---|---|
| Distribution Board | | <p data-bbox="955 764 1329 827">In new condition and generally appears to be well maintained</p> | | | <p data-bbox="2436 772 2852 869">Beyond its economic life with older equipment that will require replacement</p> |

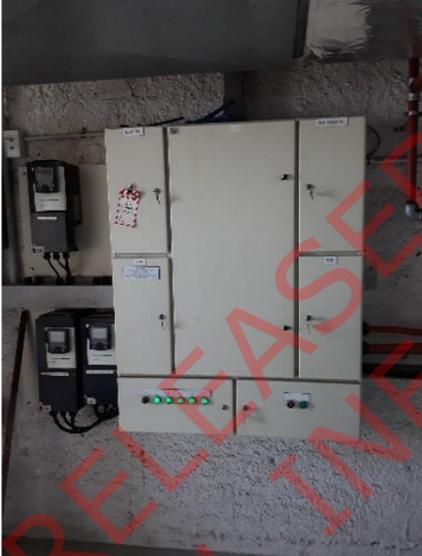
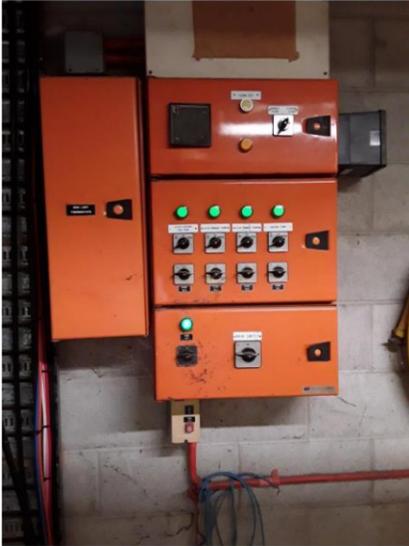
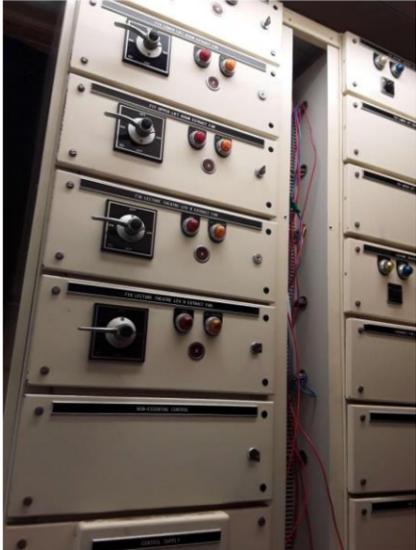
| Element example | 1 - Very Good | 2 - Good | 3 - Average | 4 - Poor | 5 - Very Poor |
|---|---|--|---|---|---|
| MCC | | <p data-bbox="955 1495 1329 1558">In new condition and generally appears to be well maintained</p> | | <p data-bbox="1911 1516 2380 1612">Whilst in moderate condition, reliability is unknown and replacement equipment is unavailable</p> | <p data-bbox="2427 1516 2873 1646">Poor condition, reliability is unknown and replacement equipment is unavailable. Visibly deteriorated, components not working</p> |

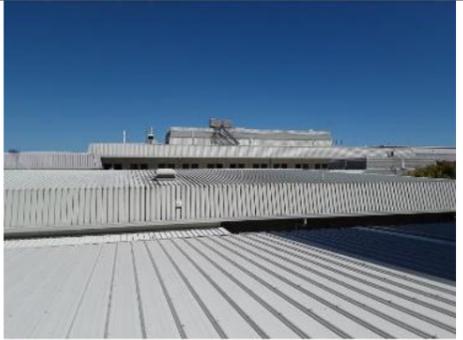
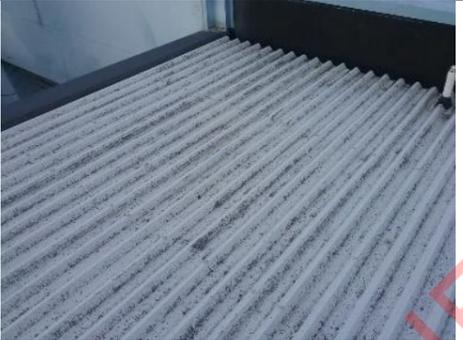
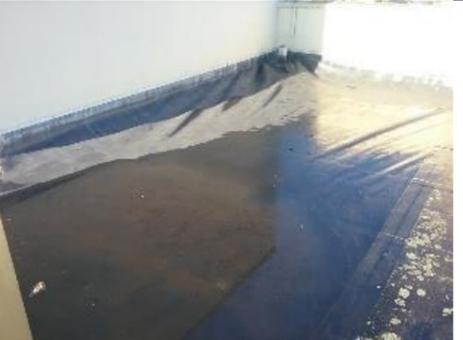
| Element example | 1 - Very Good | 2 - Good | 3 - Average | 4 - Poor | 5 - Very Poor |
|---|---|---|--|---|---|
| Fabric – External roof | | <p data-bbox="914 617 1377 709">Surface clean, free of damage and/or deflection, no surface rust, no standing water, not new</p> | <p data-bbox="1567 617 1733 642">Surface dirty</p> | <p data-bbox="2059 617 2237 642">Standing water</p> | <p data-bbox="2445 617 2861 642">Loose membrane, standing water</p> |

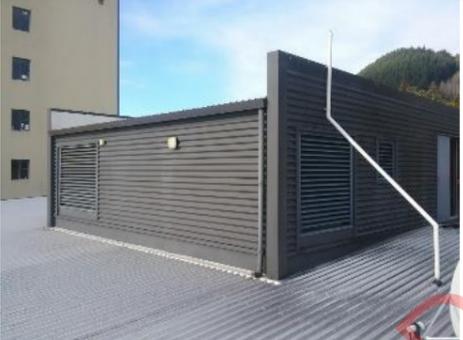
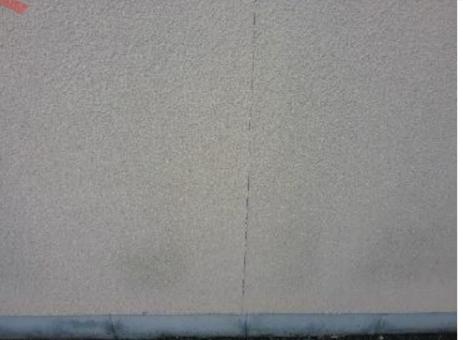
| Element example | 1 - Very Good | 2 - Good | 3 - Average | 4 - Poor | 5 - Very Poor |
|---|---|---|--|---|---|
| Fabric – External cladding | | <p data-bbox="914 1121 1377 1180">Surface clean, free of damage and/or deflection, no surface rust, not new</p> | | <p data-bbox="1941 1121 2356 1146">Vertical crack in monolithic cladding</p> | |

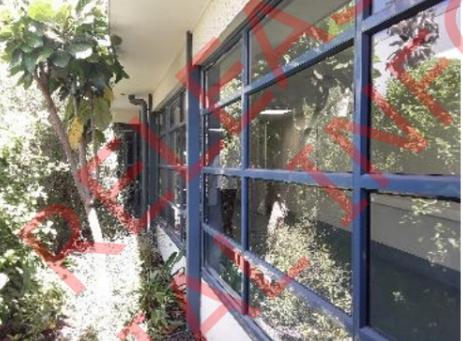
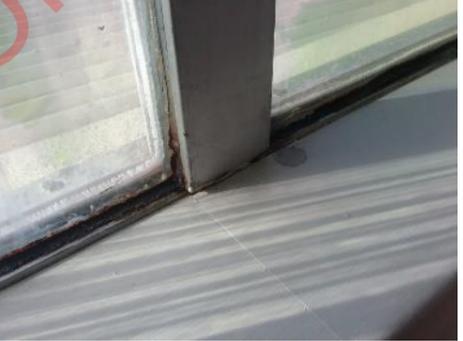
| Element example | 1 - Very Good | 2 - Good | 3 - Average | 4 - Poor | 5 - Very Poor |
|---|---|---|--|---|---|
| Fabric – External window/door | | <p data-bbox="914 1593 1377 1652">Clean, free of corrosion, seals intact, not new</p> | <p data-bbox="1555 1593 1733 1619">Minor corrosion</p> | | |

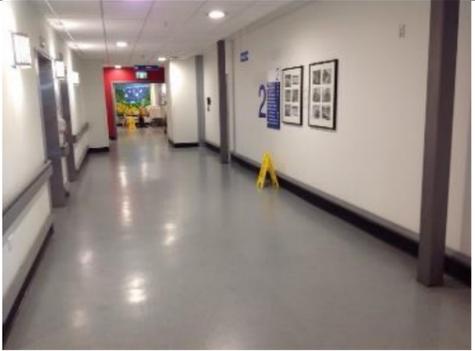
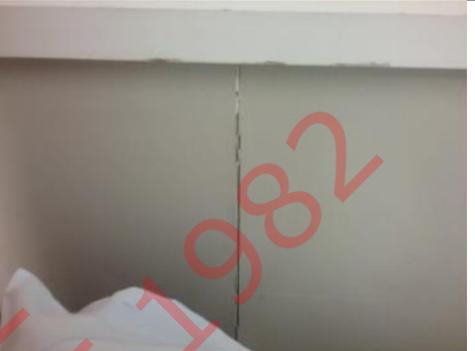
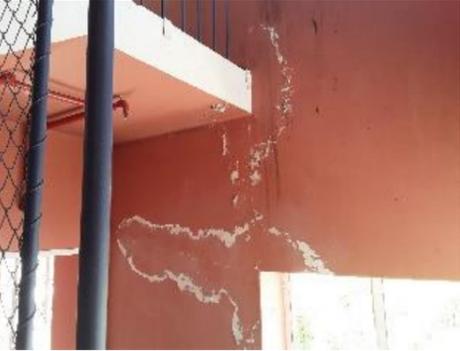
| Element example | 1 - Very Good | 2 - Good | 3 - Average | 4 - Poor | 5 - Very Poor |
|---|---|---|---|--|--|
| Fabric – Internal wall | | <p data-bbox="952 621 1338 684">No significant damage, minor scuffing, not new</p> | | <p data-bbox="2036 621 2258 653">Vertical cracking</p> | <p data-bbox="2555 621 2748 653">Water ingress</p> |

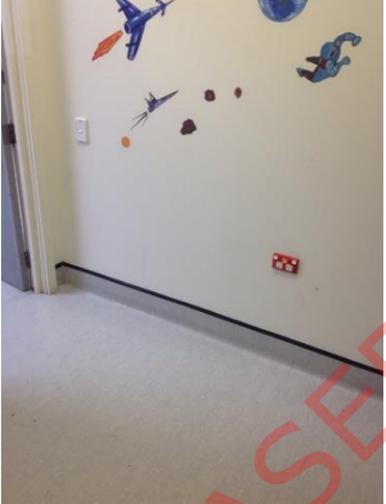
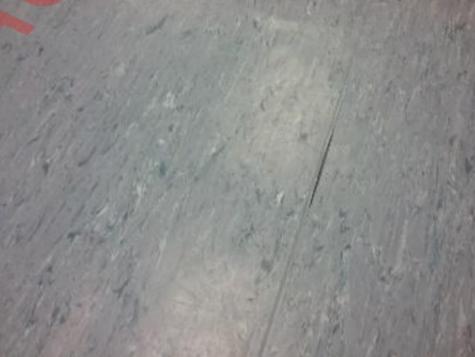
| Element example | 1 - Very Good | 2 - Good | 3 - Average | 4 - Poor | 5 - Very Poor |
|---|---|---|---|--|--|
| Fabric – Internal floor | | <p data-bbox="923 1262 1368 1325">Free of penetrations/damage, welded joints in good order, not new</p> | | <p data-bbox="2006 1115 2288 1146">Welded joint opening</p> | |

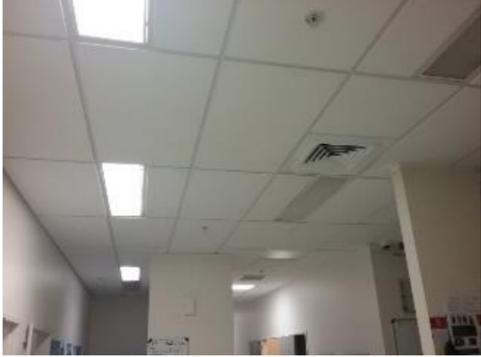
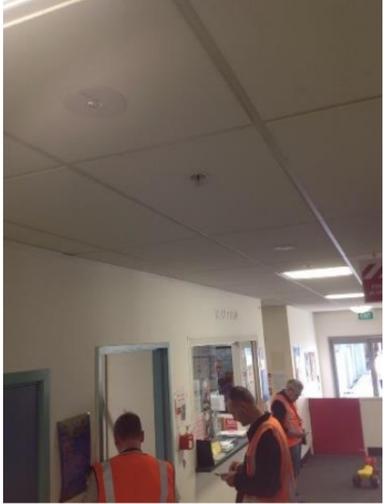
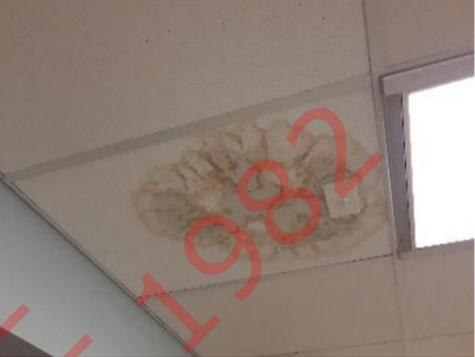
| Element example | 1 - Very Good | 2 - Good | 3 - Average | 4 - Poor | 5 - Very Poor |
|---|--|---|---|---|---|
| Fabric – Internal ceiling | <p data-bbox="424 632 863 726">Tiles and grid in good condition, no evidence of water or other damage, new or near new condition</p> | <p data-bbox="928 779 1362 842">Tiles and grid in good condition, no evidence of water or other damage</p> | | <p data-bbox="2056 632 2237 663">Water damage</p> | |
