Response to your request for official information

"1) For the critical buildings assessed for the NAMP programme but not self-assessed by DHBs, please provide - for all mental health and intellectual disability units - any data/information/documents that informed the publication of the NAMP report for these units."

Please note data presented in the Clinical Facility Fitness for Purpose reports is raw data. The raw data is then standardised into a 1 – 5 scoring matrix to remain consistent with the other National Asset Management Programme's data outputs. On this spectrum, a score of 1 is considered good and a score of 5 is considered to be poor.

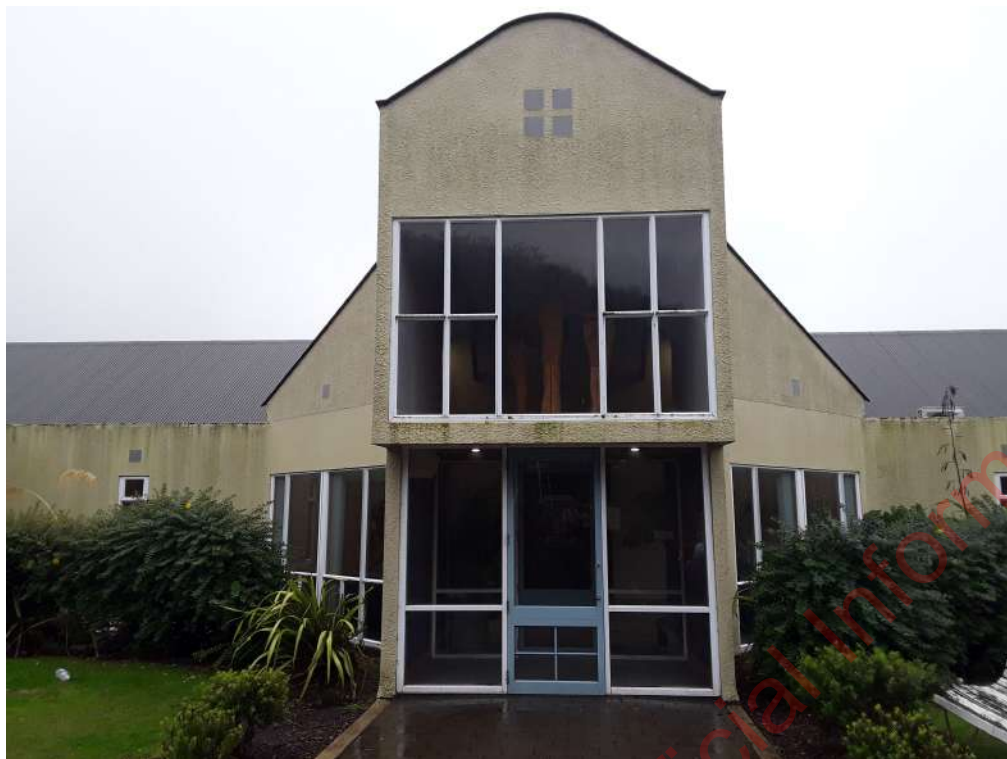
Photo of Building Exterior

Out of scope secure and Acute Unit (Wards 9A+9B) are critical buildings. Out of scope

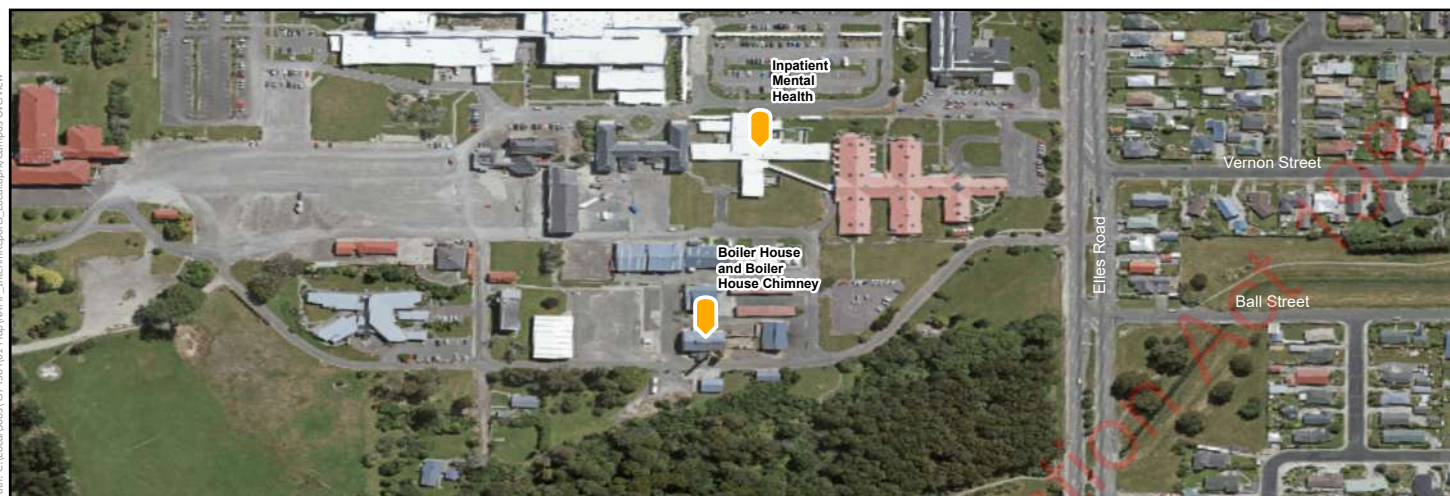
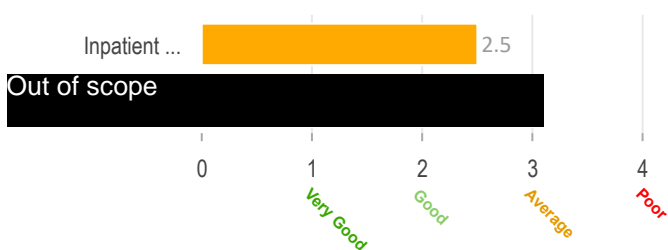
Site Overview

There are issues with blockwork cracking to block panels on the Mental Health inpatient Unit. There is roof water ingress into enclosed walkway linking Mental Health inpatient Unit with Community Mental Health

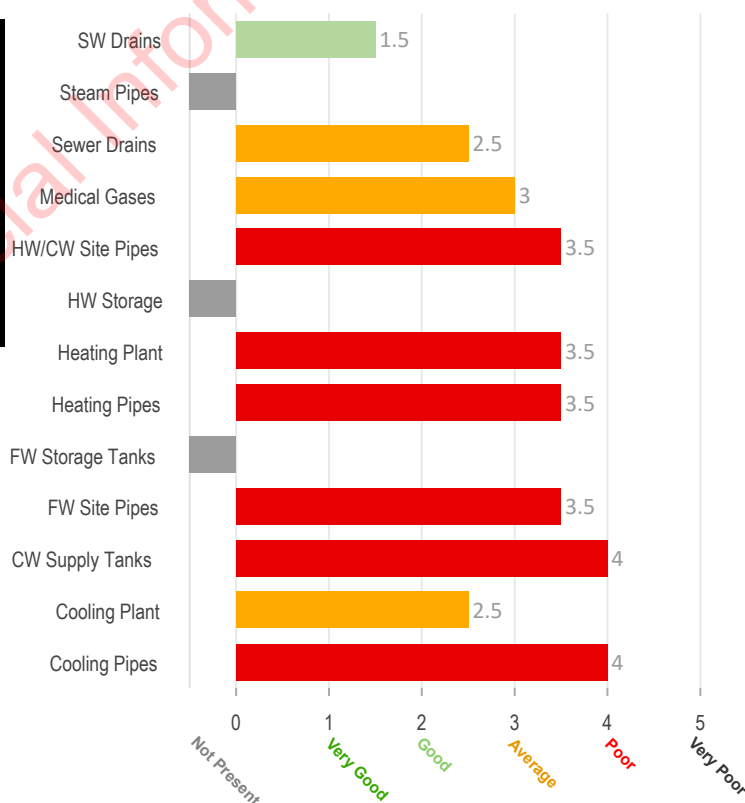
Site wide Mechanical Infrastructure Condition

Mechanical services are a mixture of average (chiller system) and poor (boiler system – dual burner but cannot work with diesel) condition. Some areas lack ventilation and active cooling. No sitewide fire storage tanks. Sitewide cold water and fire water mains are in poor condition (site staff reported asbestos cement pipes and failing valves underground – pipes themselves are average). No central medical gases and vacuum systems present.

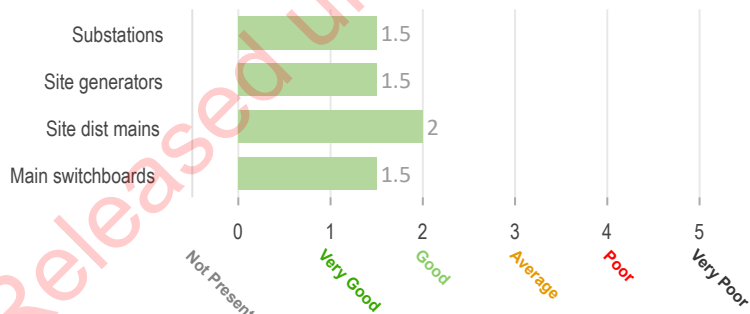
Site wide Electrical Infrastructure Condition

Site Main Switchboard has been replaced within the last 10 years. Main switchboard for Building 6 being replaced at the time of inspection.

Submains in varying condition. Some have been replaced, but others are old MIMs cables junctioned to new switchboards.

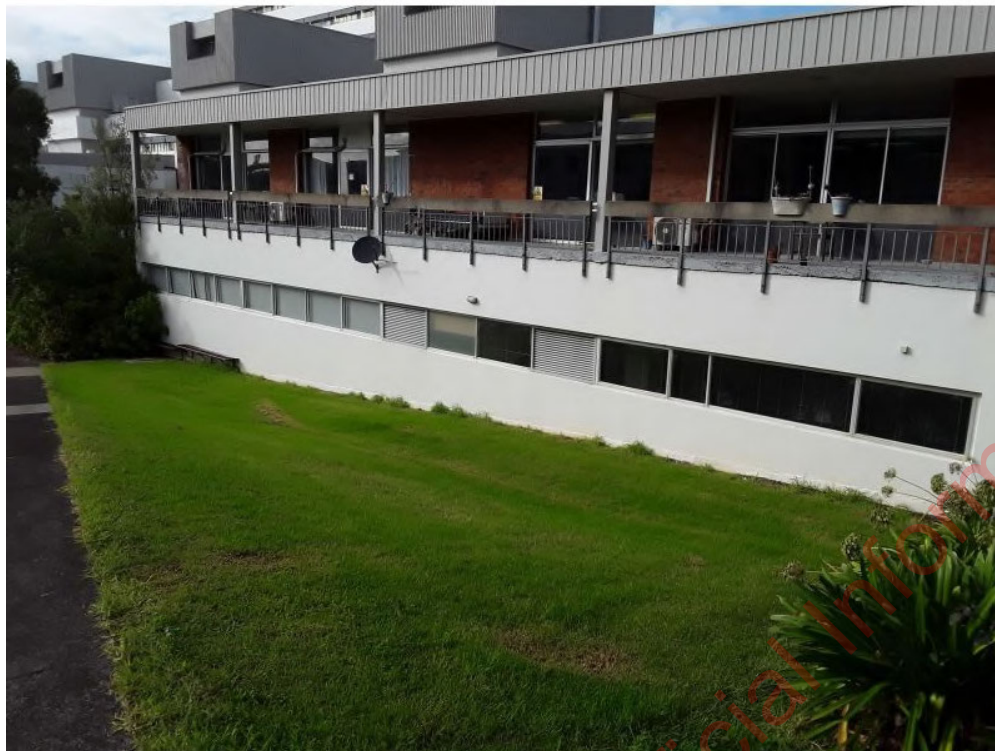
Photo of Building Exterior

Services & Fabric Score

3.3

Fire Separation Issues: Limited issues observed/known

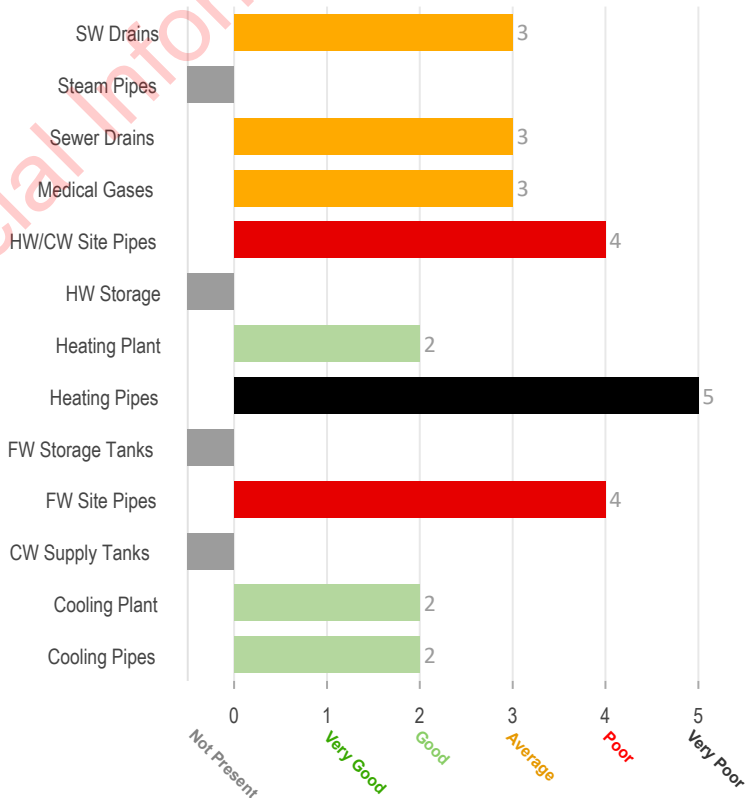
Site wide Mechanical Infrastructure Condition

Mechanical services are generally in good condition. Some areas lack ventilation and mechanical cooling. Out of scope

Heating hot water pipework in services tunnels is in very poor condition. Sitewide cold water and fire water mains are in poor conditions. No sitewide fire storage and water tanks

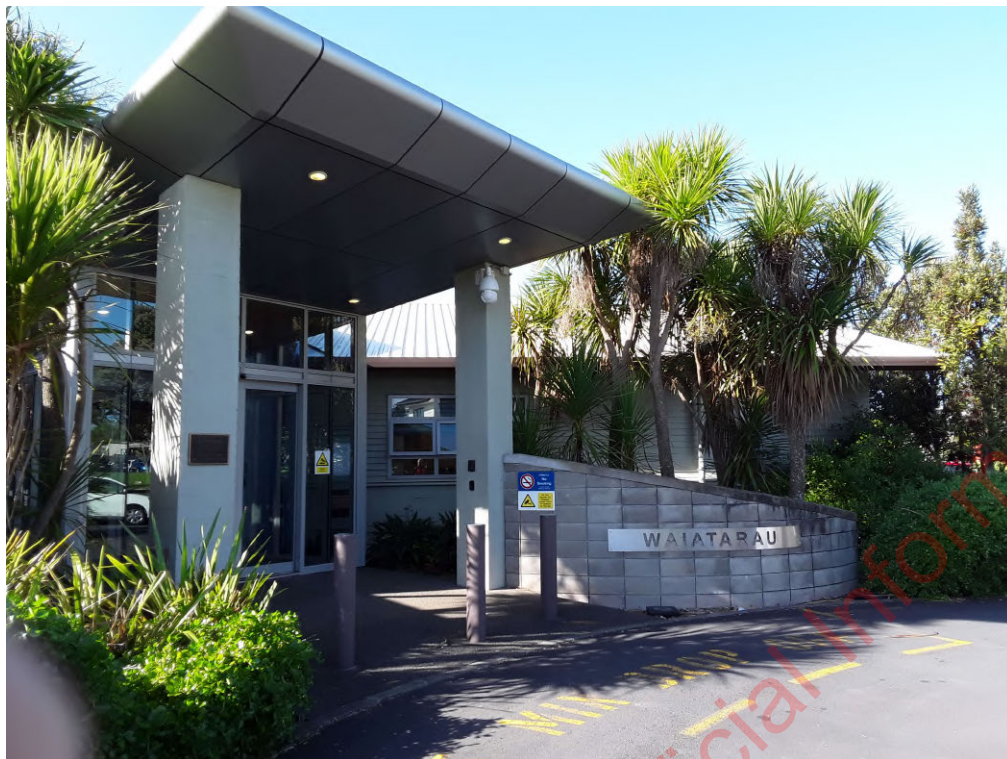
Photo of Building Exterior

Services & Fabric Score

2.4

Fire Separation Issues: Limited issues observed/known

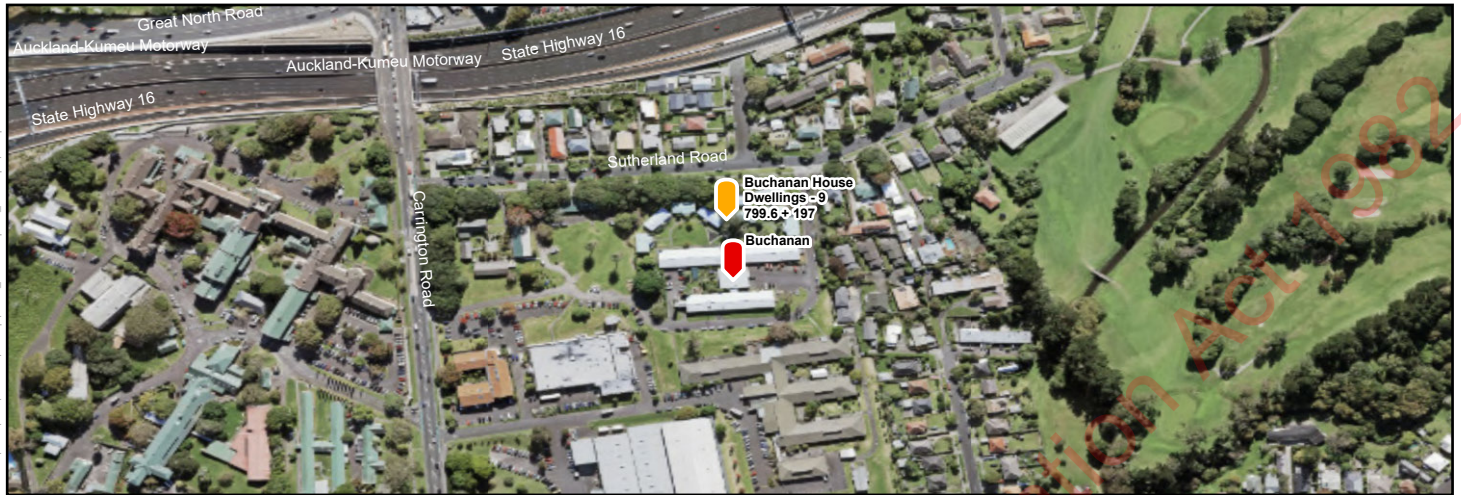
Site Overview

Generally buildings inspected were of average condition. Roof maintenance to the House Dwellings will help prolong their life. Known Asbestos issues.

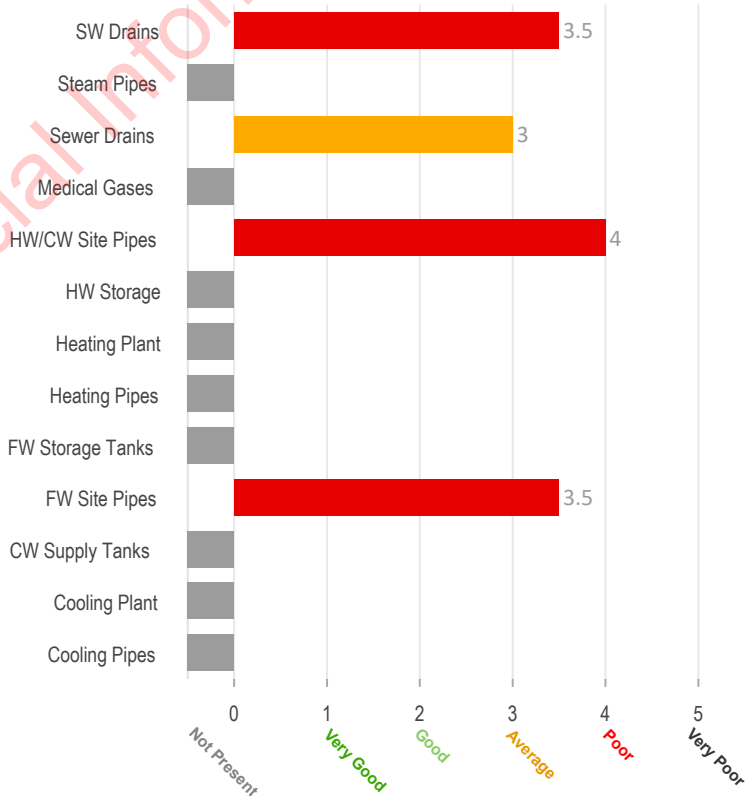
Site wide Mechanical Infrastructure Condition

Mechanical services were generally of average to poor condition. Equipment are original and generally near the end of their economical life. Some areas lack ventilation and active cooling. No sitewide fire and water storage tanks. No central medical gases and vacuum systems present.

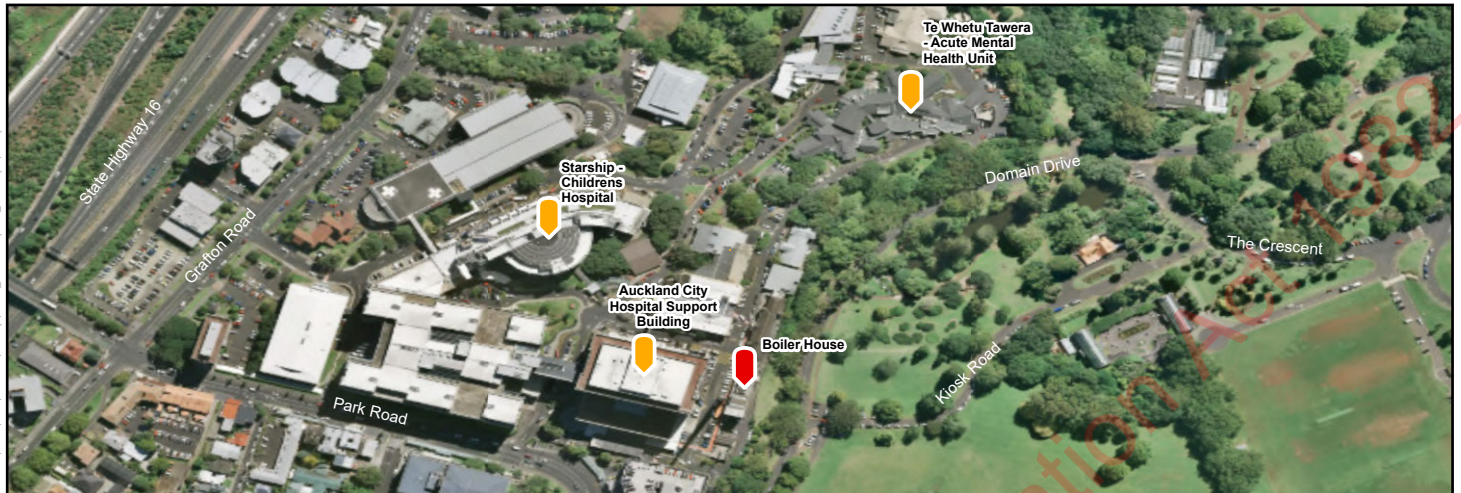
Site Overview

Generally buildings inspected were of average condition except the Boiler House which was poor condition. Internal fabric of the buildings generally faring better than the exterior. Main deficiencies noted are the failing of roofing, particularly waterproofing membranes and sheet cladding at the Mental health unit. Significant known Asbestos issues.

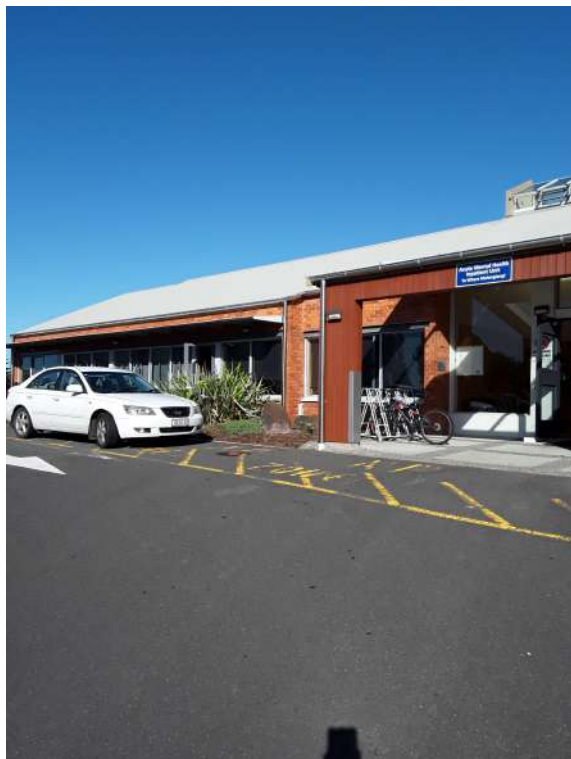
Photo of Building Exterior

Fire Separation Issues: Limited issues observed/known

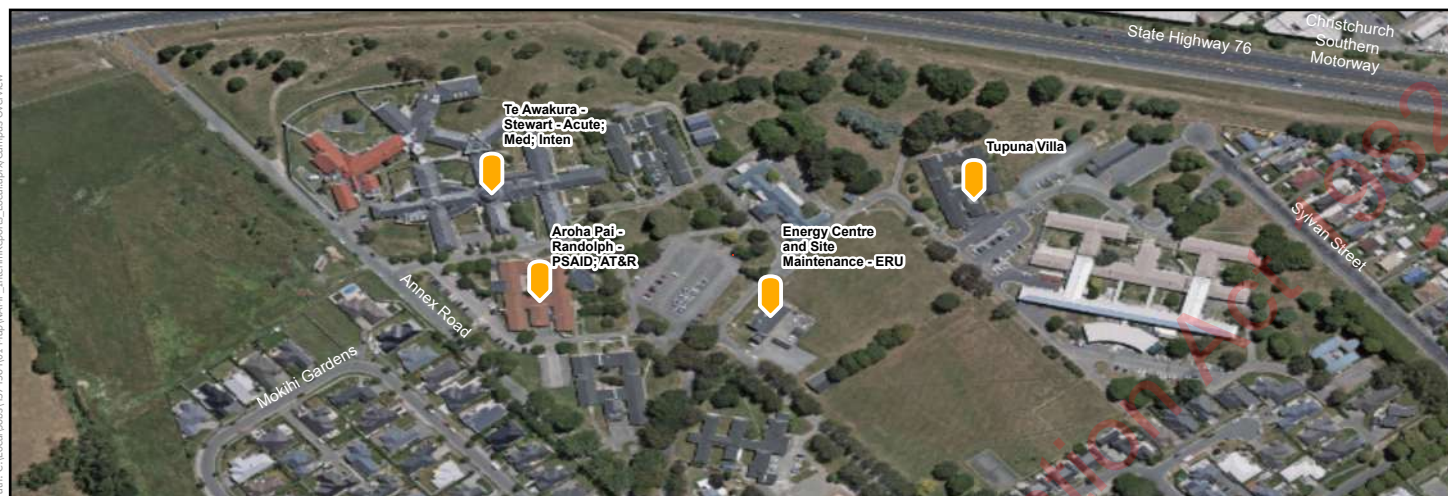
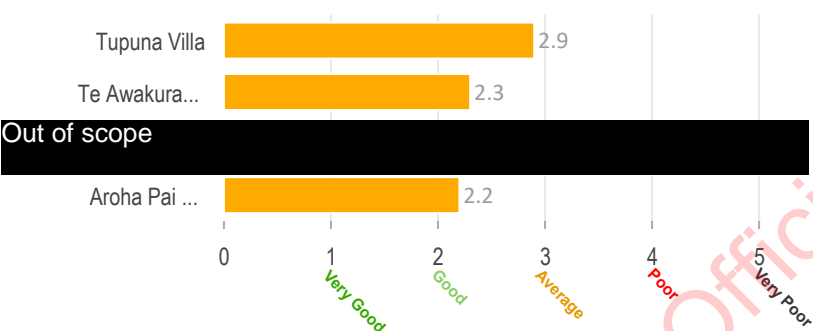
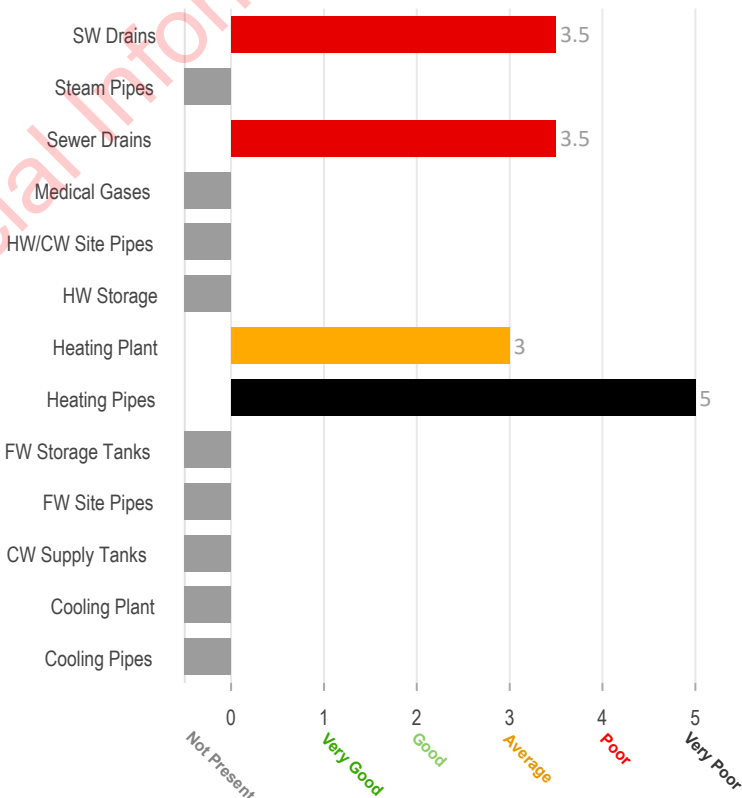
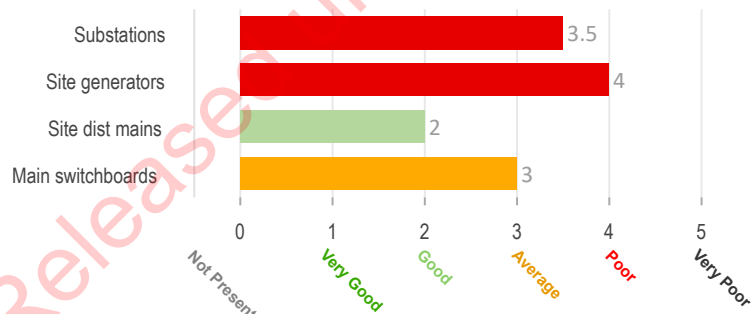
Site Overview

Generally single level buildings from the 1960's, 70's and 80's in average condition and showing their age. The 1974 Tupuna Villas have asbestos containing cladding panels.

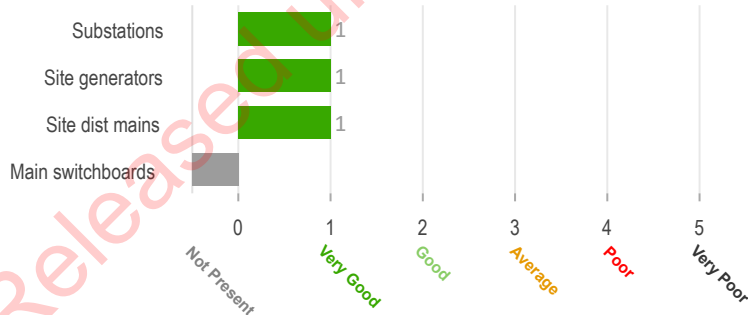
Site wide Electrical Infrastructure Condition

Site wide electrical infrastructure appears in good condition. Out of scope

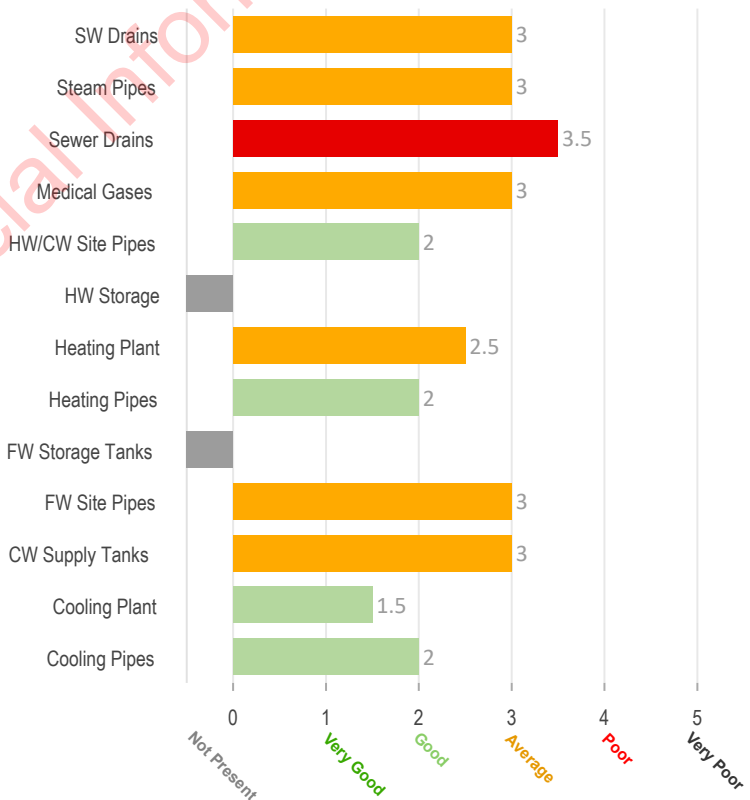
Site wide Mechanical Infrastructure Condition

Major refurbishment undertaken circa 2012 therefore mechanical assets in good condition. Some 'backbone' infrastructure is original and will be beyond its life expectancy. Condition monitoring programme is recommended. Out of scope

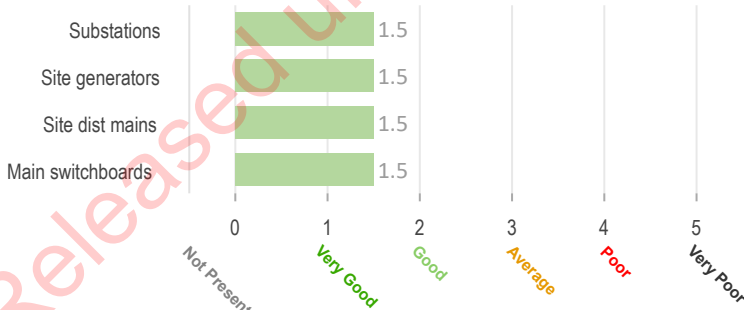
Site wide Electrical Infrastructure Condition

The electrical infrastructure is generally in good condition with some small variability in some of the older buildings. Out of scope

original electrical infrastructure is likely to require replacement in the near future.

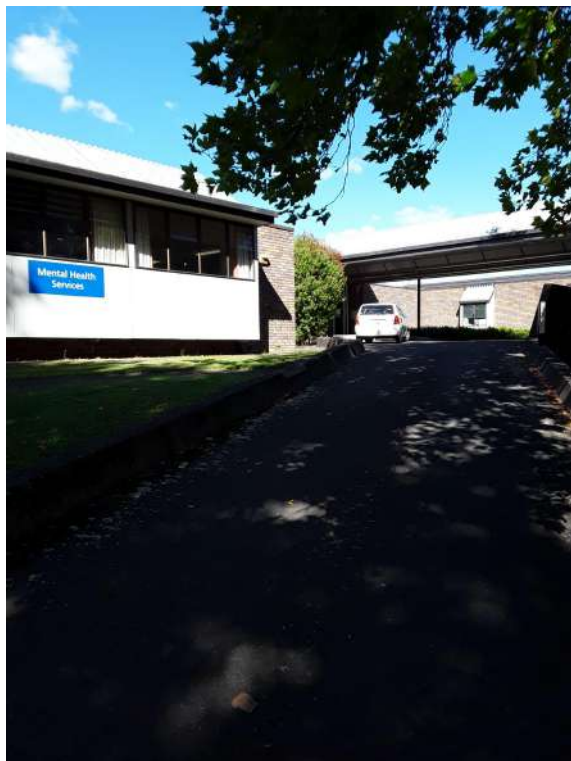
Photo of Building Exterior

2.4

Fire Separation Issues: Limited issues observed/known

Asbestos Issues: Limited issues observed/known

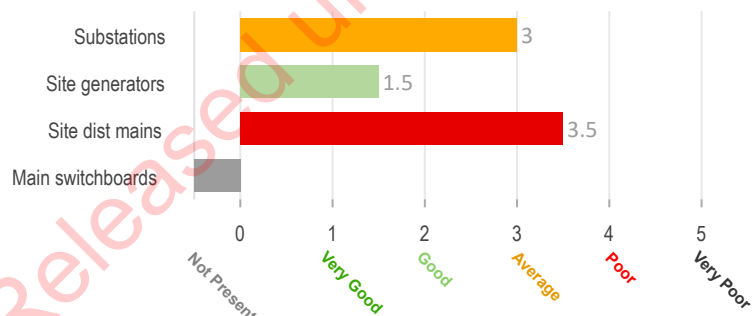
Site wide Electrical Infrastructure Condition

Generally buildings inspected were of average condition with aging electrical infrastructure nearing the end of its life expectancy.

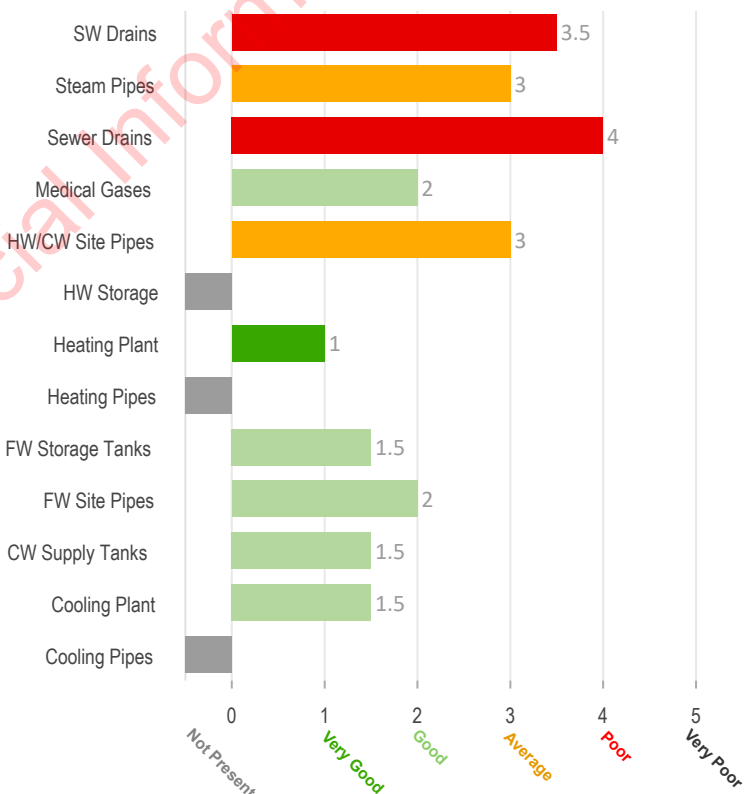
Site wide Mechanical Infrastructure Condition

Generally services in older buildings are aging and nearing the end of life expectancy, replacement or major refurbishment is required. Some "backbone" infrastructure is original and condition monitoring is recommended. There is no cooling in inpatient ward areas which is not considered appropriate in clinical buildings.

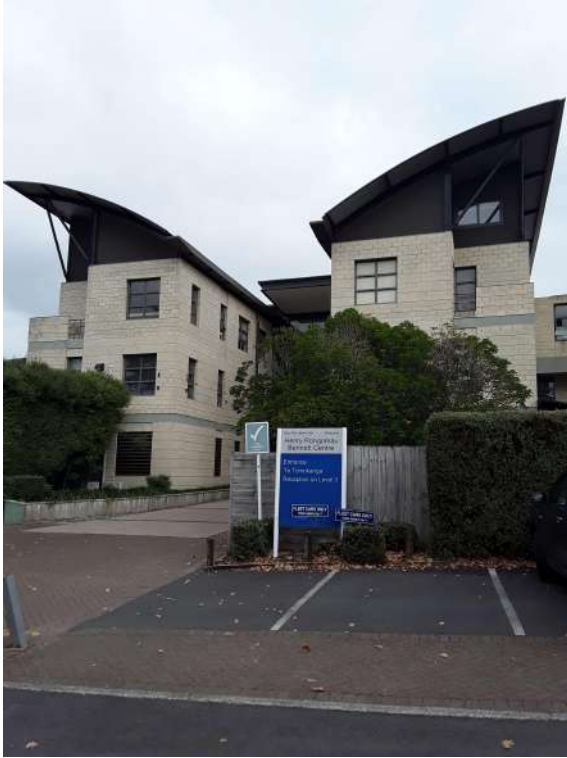
Photo of Building Exterior

Services & Fabric Score

2.2

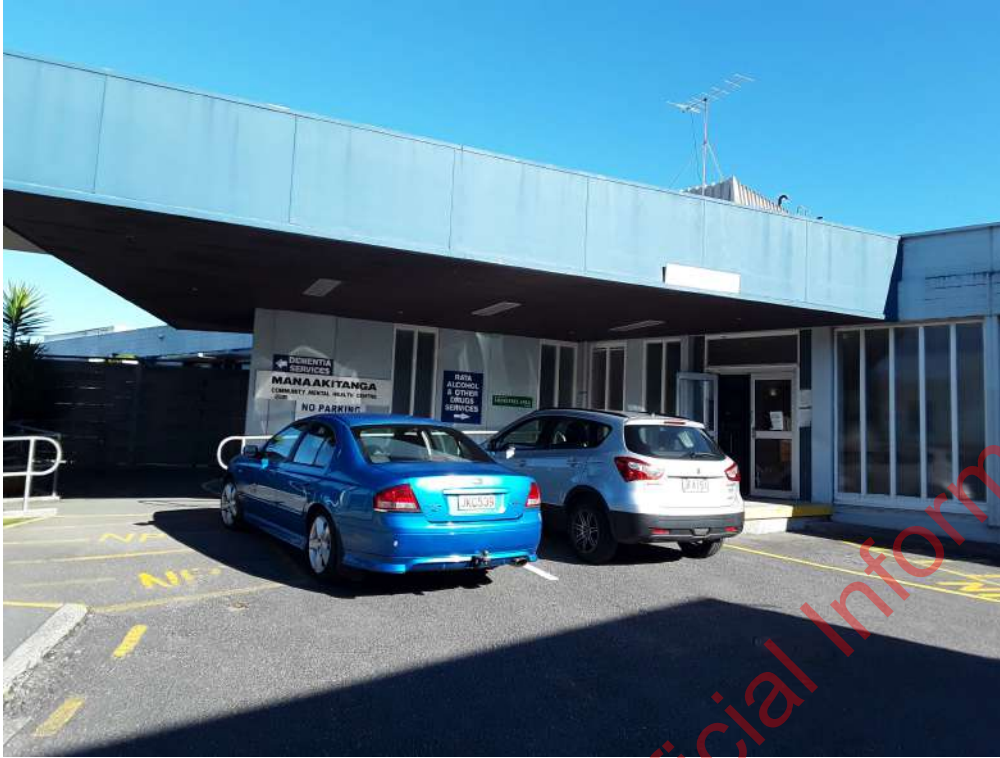
Photo of Building Exterior

The external building fabric for the Mental Health unit is in reasonable condition, however the roof has had patched repair and is nearing end of life. Internally, a large proportion of the upper floor has been recently refurbished, however the ground floor fitout is largely original. The electrical infrastructure appeared to be in good condition for its age, with new submains from recently replaced main switchgear. The main site switchboard is located external to the buildings within a container. Whilst not an ideal location, it appeared to be in good condition. HVAC plant serving the building are in poor condition. Hot water services are being decentralised at present. Cold water services showing signs of age. New central boiler plant (not reviewed) is currently being commissioned.

Services & Fabric Score

3.2

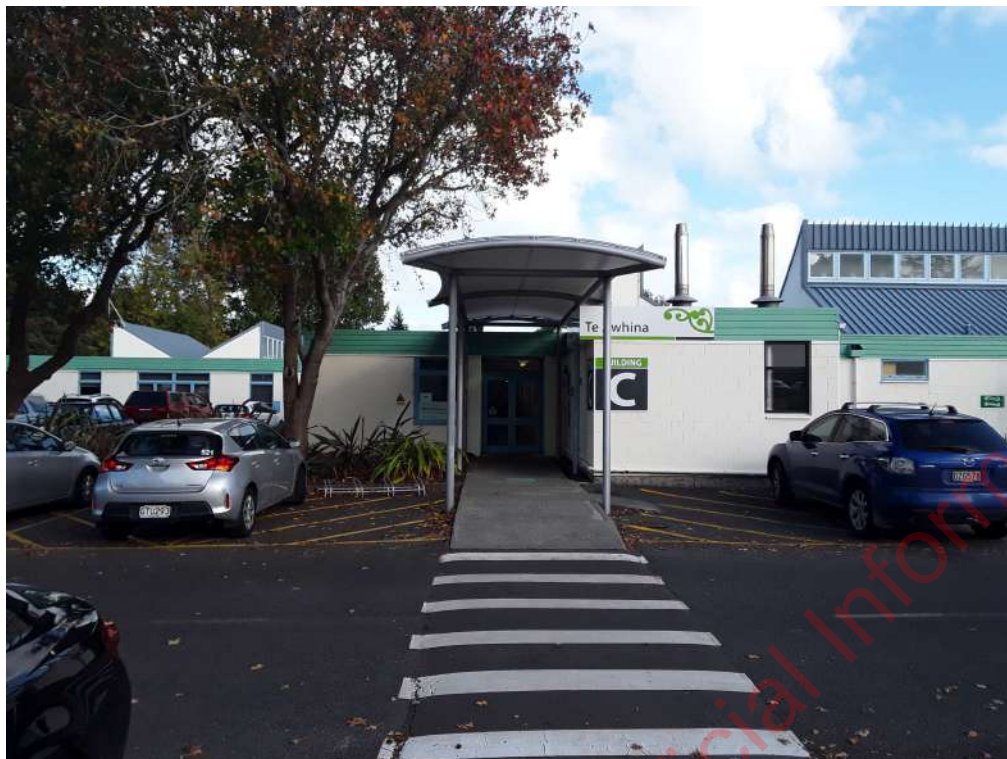
Photo of Building Exterior

Services & Fabric Score

2
