#### Response to your request for official information

#	Date	Title	Decision on release
1	27 August 2019	Kenepuru Hospital Building and Infrastructure Condition Report	Released in full
2	28 August 2019	Hutt Hospital Building and Infrastructure Condition Report	Released in full
3	29 August 2019	Wairarapa Hospital Building and Infrastructure Condition Report	Released in full
4	30 August 2019	Hawkes Bay Hospital Building and Infrastructure Condition Report	Released in full
5	2 September 2019	Mid-Central District Health Board - Clinical Facility Fitness for Purpose	Released in full
6	2 September 2019	Hawkes Bay District Health Board – Clinical Facility Fitness for Purpose	Released in full
7	3 September 2019	Capital and Coast District Health Board – Clinical Facility Fitness for Purpose	Released in full
8	3 September 2019	Hutt Valley District Health Board – Clinical Facility Fitness for Purpose	Released in full
9	9 September 2019	Palmerston North Hospital Building and Infrastructure Condition Report	Released in full

#### **Site Overview**

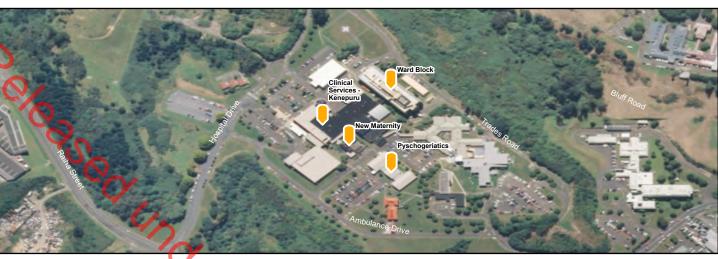
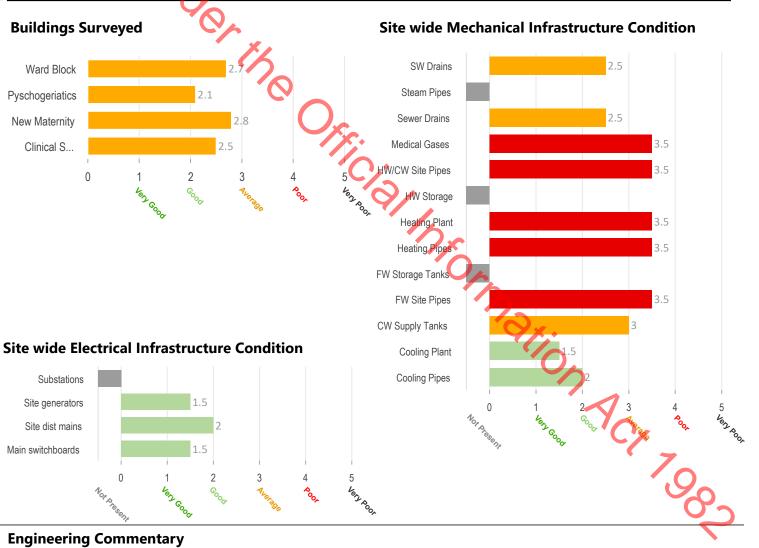
The Ward Block building roof and upper metal and timber cladding materials are in poor condition. The New Maternity block is a relocated cafeteria building and is in average condition. The Clinical Services Keneperu (CSK) building has weathertightness issues with roof leaks.

Site Main Switchboards have been replaced within the last 5 years and in good condition. Old submains jointed under floor to new switchboard. Generator has been replaced within last 3 years, has adequate capacity to supply 100% site load and in good condition. Main switchboard for Ward Block is due for replacement.

Mechanical services were generally of good (chiller system) to average (boiler system) condition. Some areas lack ventilation, active cooling and heating. Appeared to be no sitewide fire storage tanks and separate fire ring main.

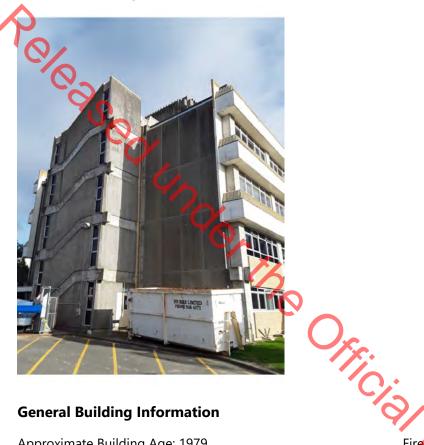
#### **Photo of Building Exterior**

Approximate Building Age: 1979

Fire Separation Issues: Limited issues observed/known

Asbestos (ssues: Limited issues observed/known

Seismic Services Restraint: Moderate

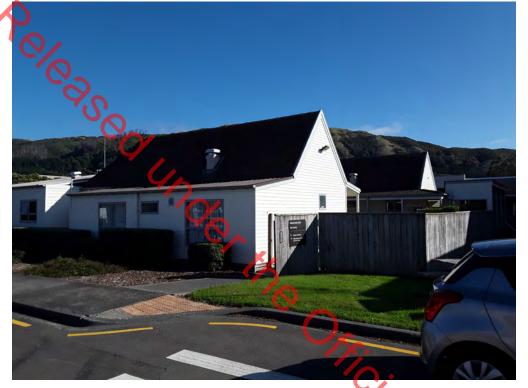
#### **Photo of Building Exterior**

Approximate Building Age: 1990

Fire Separation Issues: Limited issues observed/known Asbestos issues: Low likelihood of issues

Seismic Services Restraint: Poor

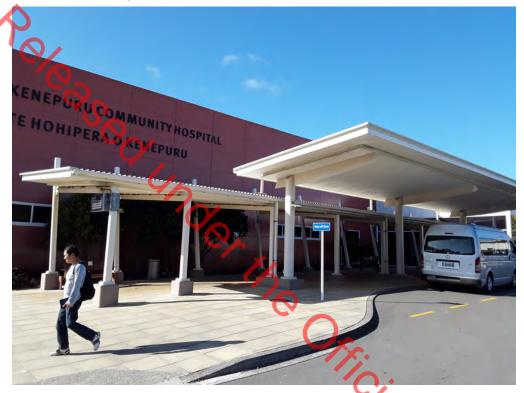
#### **Photo of Building Exterior**

Approximate Building Age: 1979

Fire Separation Issues: Limited issues observed/known Asbestos Issues: Limited issues observed/known Seismic Services Restraint: Moderate

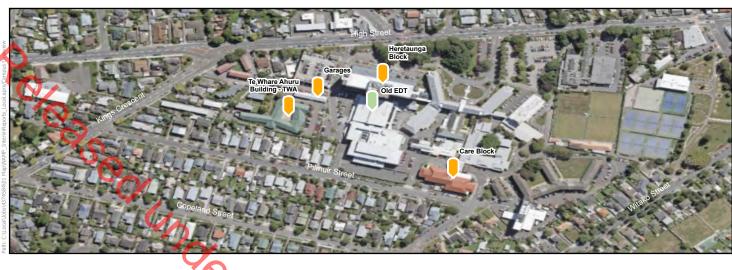
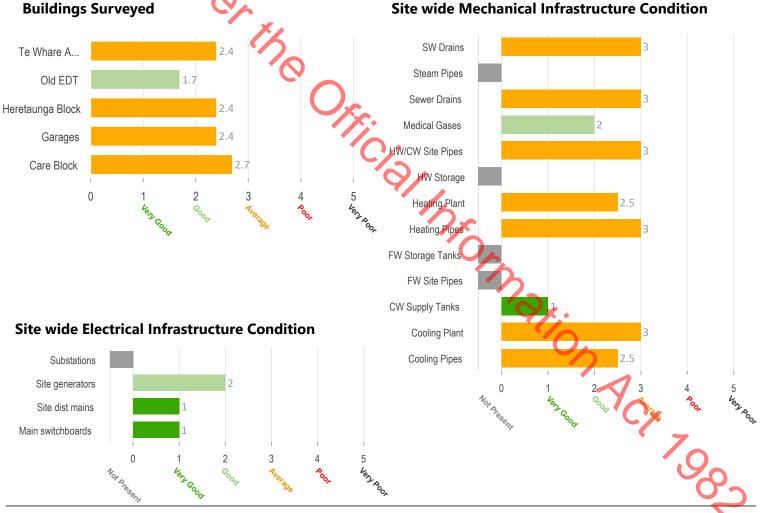
#### **Site Overview**

The Care Block is in average condition with evidence of moisture entering through stair core walls and five different cladding materials may cause maintenance issues in the future. Te Whare Ahuru (TWA) is in average condition. The residential timber frame construction with monolithic sheet cladding is cracking and likely to be letting moisture into the wall framing. The main client concern is the 3 waters as the condition of 80 year old direct buried pipework is unknown.

Electrical infrastructure is generally in good condition. The generator has recently been replaced as part of the theatre upgrade project including new controls systems. Limited variability and good distribution condition.

Mechanical infrastructure is generally in good condition with little variability. There is no cooling in inpatient ward areas which is not considered appropriate in clinical buildings. This is particularly evident in the Maternity and Ward (Heretaunga) building.

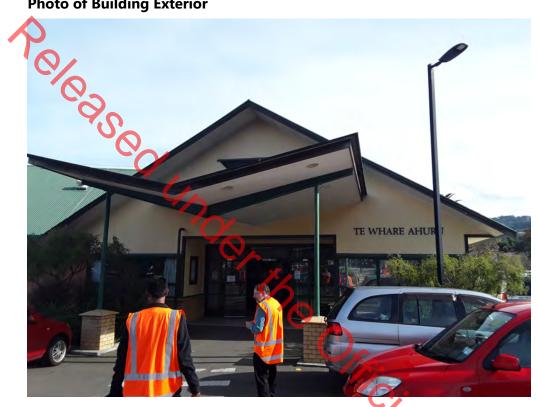
#### **Photo of Building Exterior**

Approximate Building Age: 1997

Fire Separation Issues: Limited issues observed/known Asbestos issues: Low likelihood of issues

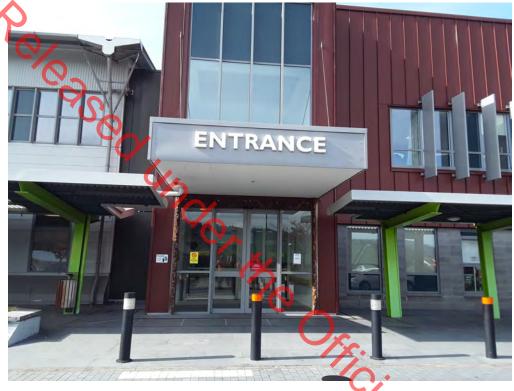
#### **Photo of Building Exterior**

Approximate Building Age: 1997

Fire Separation Issues: Limited issues observed/known Asbestos issues: Low likelihood of issues Seismic Services Restraint: Good

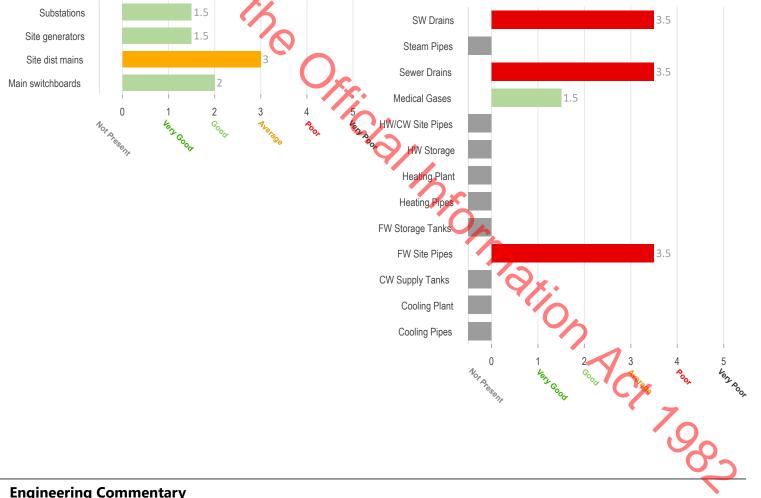
#### Site wide Mechanical Infrastructure Condition

Only the sitewide infrastructure has been assessed. Wairarapa DHB buildings were not selected for professional assessment due to the recent construction of the main hospital building. The DHB does not have a mental health inpatient unit. Site wide reticulated infrastructure was inspected by a Ministry official and has not been verified by Beca. Main reticulated infrastructure had been upgraded when the main hospital building was built a little over a decade ago. The older facilities are on older infrastructure, which is not currently causing concern. There were some operational issues related to design, waste water and storm water reticulation to the new hospital building but these have been managed.

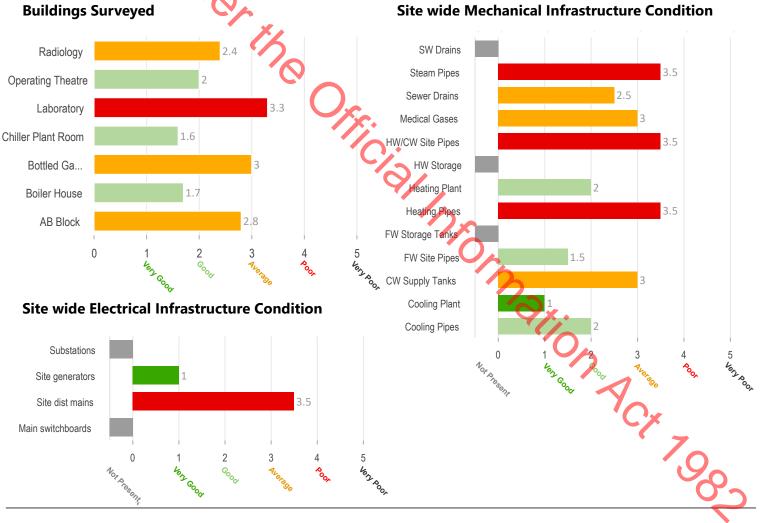
The bulk of the departments are in buildings of varying age and joined at ground floor level. The joined buildings bring passive fire separation complexities which appear to be reasonably well managed at this time. The Laboratory is located on the fist floor and straddles the Emergency and Radiology departments. Roof leaks are occurring due to the dissimilar footprints of the two storeys. In general the electrical infrastructure is near or beyond it's economic life. The HV supply to the site is poor and has regular failures. Some major switchgear is vulnerable and may fail particularly the Theatres.

The mechanical infrastructure is generally in an average condition and is near/at the end of useful economic life. Pipework throughout the campus is original and a monitoring programme is recommended. Inpatient ward area lack cooling which is not considered appropriate for clinical areas.

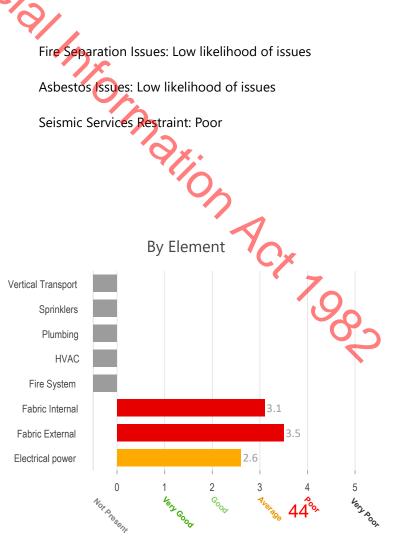
### Summary of building condition

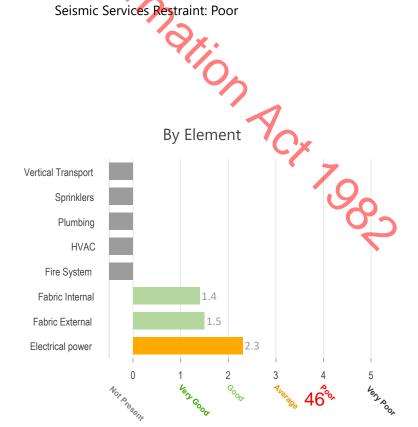
#### Summary of building condition

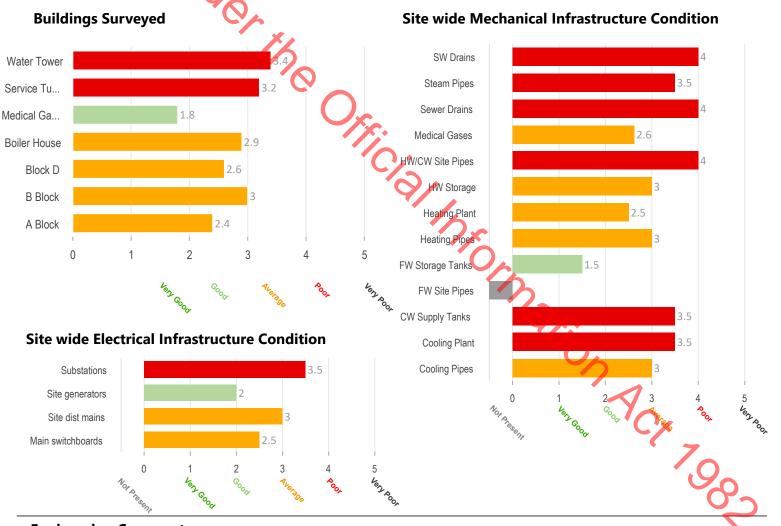
The boiler chimney appears ok but there is a risk that it could collapse onto other buildings in an earthquake. Anecdotal evidence suggested there are historic structural, fire separation and building fabric issues on several other buildings. There appeared to be a lot of organic growth on the walls and roof forms of taller buildings; inferring routine maintenance is not occurring frequently.

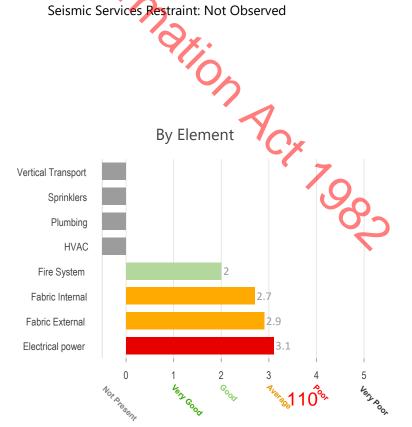
### Summary of building condition

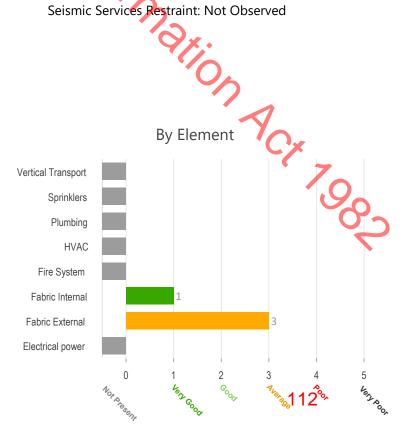
### Summary of building condition

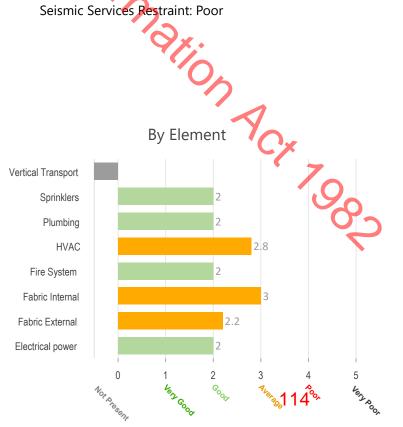
### Summary of building condition

Fire Separation Issues: Limited issues observed/known Asbestos issues: Low likelihood of issues Seismic Services Restraint: Poor

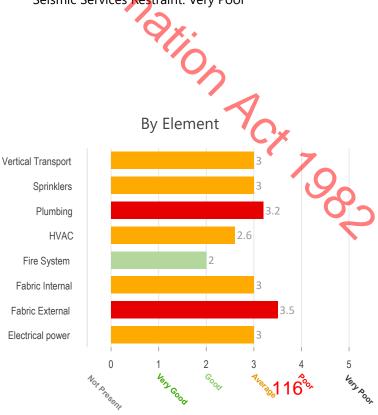
### Summary of building condition

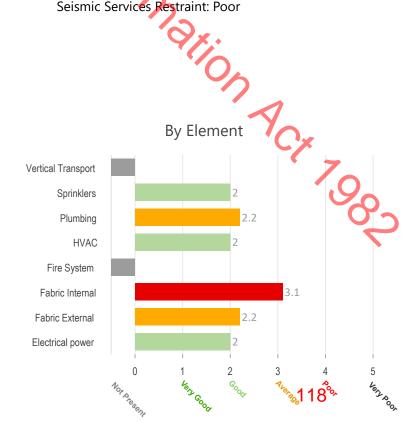
### Summary of building condition

Fire Separation Issues: Limited issues observed/known Asbestos issues: Low likelihood of issues Seismic Services Restraint: Poor

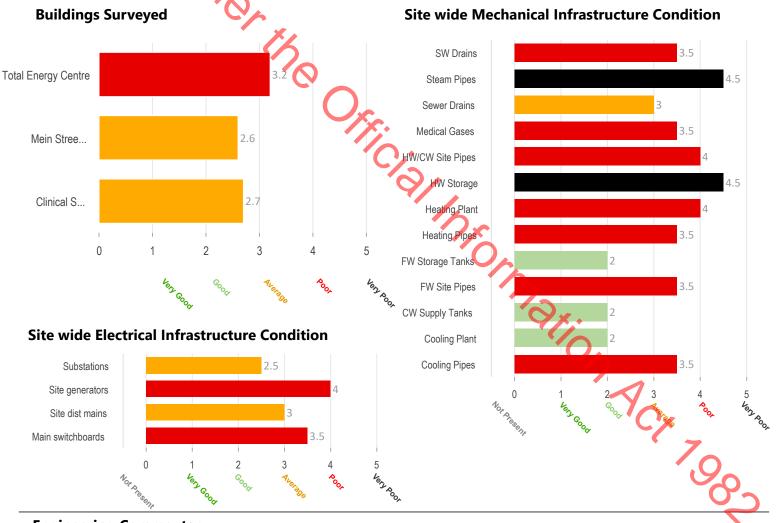
### Site Overview

A key concern is the Energy Centre (TEC) as elements of the envelope contain asbestos and are preventing roof access. We understand there are concerns some key site services are not located on drawings.

Hospital owns 11kV site infrastructure. Majority of HV cabling around site generally appear to be beyond life expectancy and should be replaced. Site LV MSB at end of life expectancy and replacement is being investigated.

Mechanical services were generally of average (boiler system) to good (chiller system) condition. Domestic and heating hot water valves, pumps and storage tanks in Total Energy Centre were in poor condition which require constant attention.

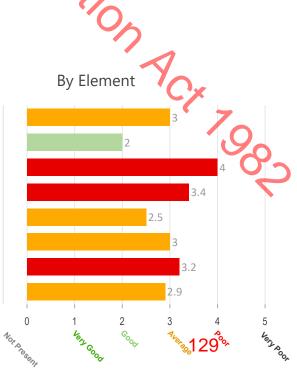
Fire Separation Issues: Limited issues observed/known Asbestos Issues: Significant known issues Seismic Services Restraint: Poor

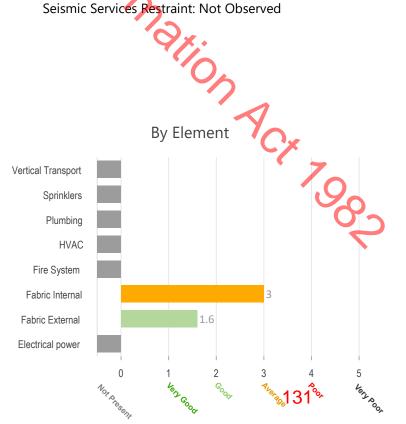
### Summary of building condition
