All about **Asbestos**

Protecting your health at home

Citation: Ministry of Health. 2017. *All about Asbestos: Protecting your health at home*.
Wellington: Ministry of Health.

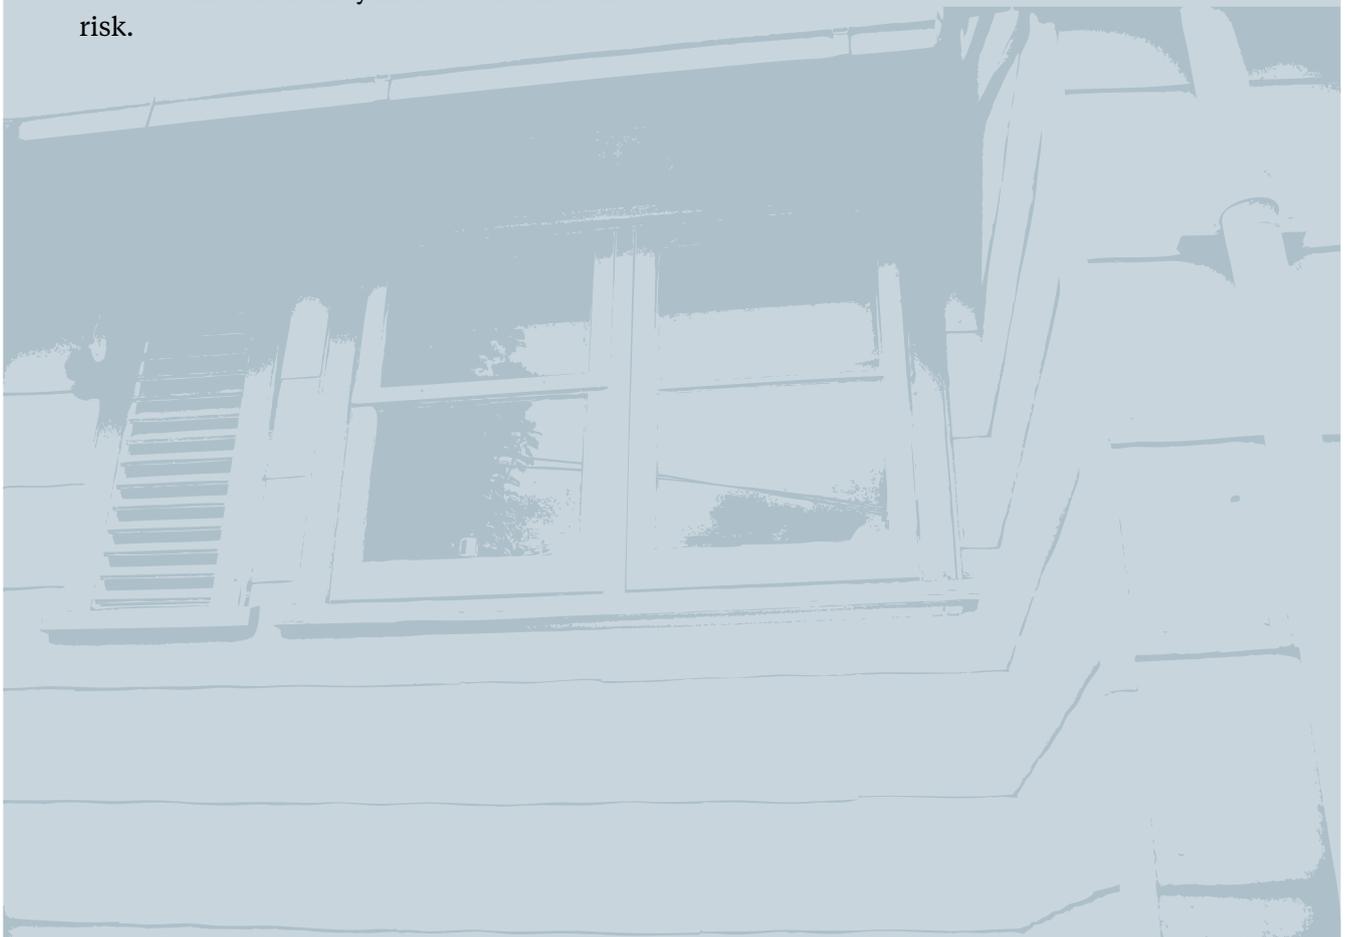
Table 1: Residential risk assessment based on age of home, presence of asbestos-containing materials and activities that could increase or decrease risk to people

Building age	Possible asbestos-containing materials present	Status of asbestos-containing materials if present	Activities impacting asbestos-containing materials and exposure	Risk level
Pre-1940 unrenovated	None likely			None or negligible risk
Pre-1940, renovations performed 1950–1985	Exterior – corrugated cement roofing, Fibrolite or Hardiplank cladding, Fibrolite eaves	Cracks, chips or breaks in roofing or exterior cement sheeting (walls and eaves)	Materials wet during removal, not sanded or drilled, OR materials sealed/encapsulated	Extremely low risk
			Present when damaged materials were sanded or drilled	Possible short-term exposure – very low risk
		Materials undamaged and well-maintained (sealed and painted)		Extremely low risk
	Interior – textured ceilings, wall linings, vinyl flooring	Decorative ceiling crumbling or removed, vinyl flooring uplifted or old wall board crushed or drilled	Present during removal, but clean-up thorough	Possible short-term exposure – very low risk

Home furnishings contaminated with dust, not cleaned or removed	Low risk but possible ongoing low-level exposure*
		Materials intact		Extremely low risk
1940–1990	Exterior – corrugated cement roofing, Fibrolite or Hardiplank cladding, Fibrolite eaves	Cracks, chips or breaks in roofing or exterior cement sheeting (walls and eaves)	Materials wet during removal, not sanded or drilled, OR materials sealed/encapsulated	Extremely low risk
			Present when damaged materials were sanded or drilled	Possible short-term exposure – very low risk
		Materials undamaged and well maintained (sealed and painted)		Extremely low risk
	Interior – textured ceilings, wall linings, vinyl flooring	Decorative ceiling crumbling or removed, vinyl flooring uplifted or old wall board crushed or drilled	Present during removal but clean-up thorough	Possible short-term exposure – very low risk
			Home furnishings contaminated with dust, not cleaned or removed	Low risk but possible ongoing low-level exposure*

□ = possible presence of a hazard but probable low risk, ■ = minimised risk, ■ = ongoing presence of the hazard and higher risk.

Table 1 outlines the risk of asbestos exposure based on the age of a home and the presence of asbestos-containing materials in the home structure. The materials should be assumed to be asbestos-containing materials if there is uncertainty.
